## CASE HISTORY

**TRACKBED STABILIZATION USING TECHGRID BIAXIAL GEOGRID AND NONWOVEN GEOTEXTILE FROM KM: 323/0 TO 323/2 BETWEEN JAMGURI & OATING STATIONS GOLAGHAT DISTRICT, ASSAM**  
GOLAGHAT, ASSAM, INDIA

### Trackbed Stabilization

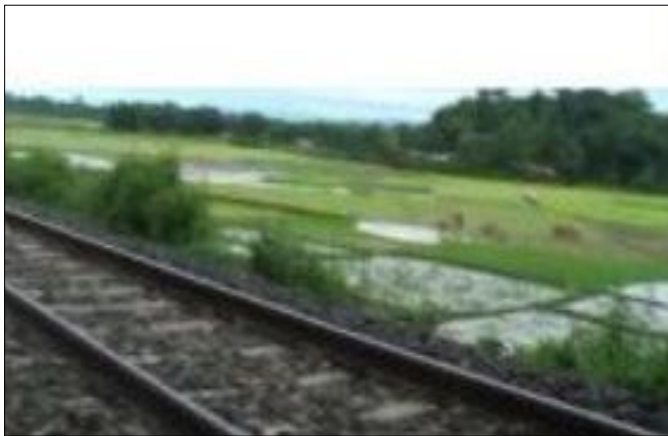
**Photo 1 : Site before rehabilitation**

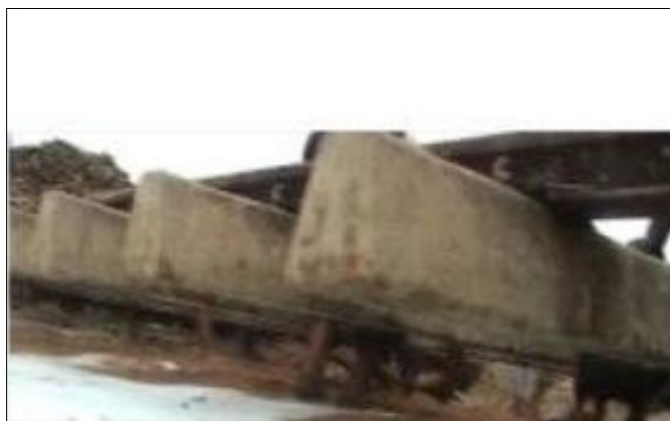
Photo 7 : Spreading sand above geotextile

- Laying of the geotextile over the sand layer without any folds or wrinkles (photo 6).
- Spreading of a thin layer of sand (approximately 50mm thick) over the geotextile (photo 7).
- Installing the geogrid over the second layer of sand (photo 8).
- Placing and compacting cleaned ballast over the geogrid (photo 9).

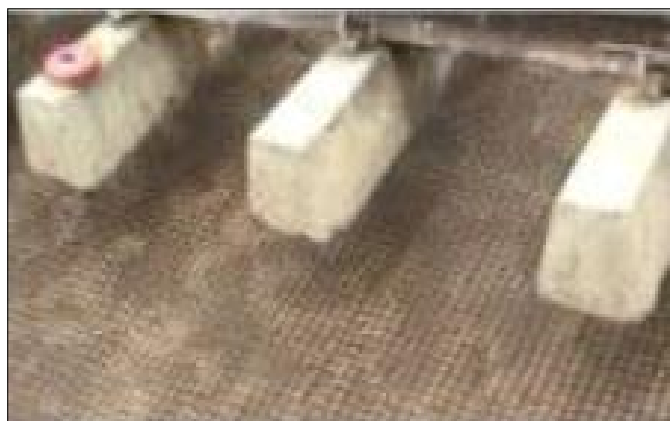
Photo 8 :Laying Techgrid TGB-40 Knitted Polyester Biaxial Geogrid

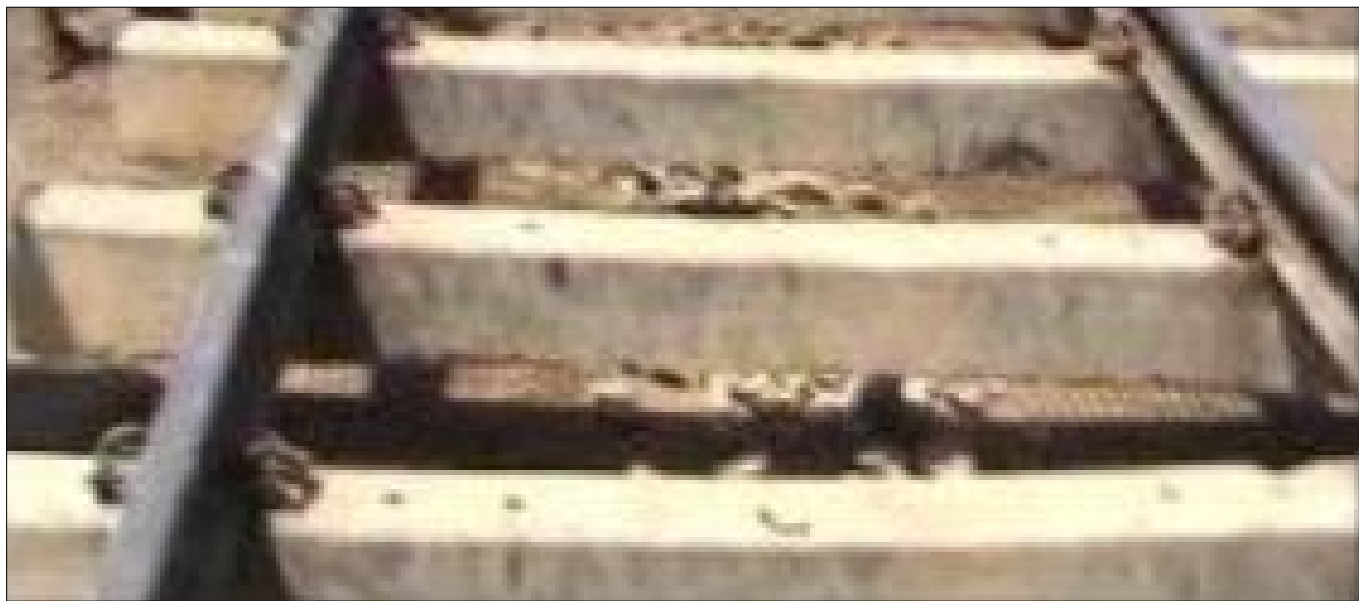
**Photo 9 : Placing ballast over the geogrid**

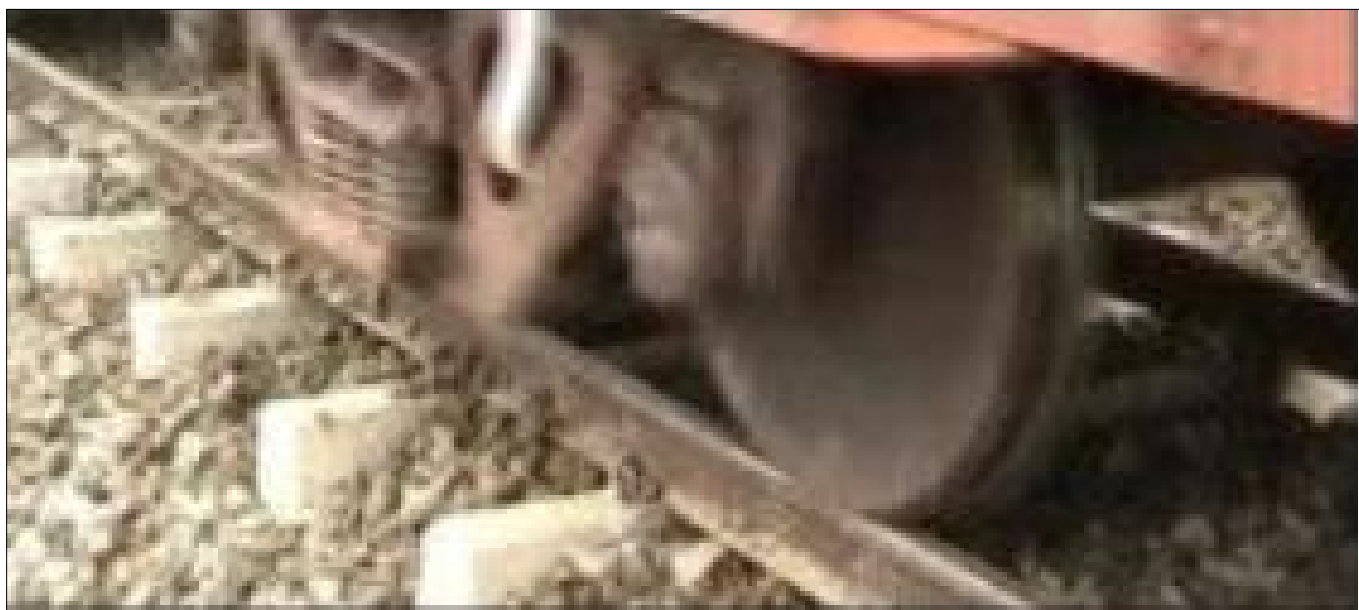
**Photo 10 : Train running over the rehabilitated track**

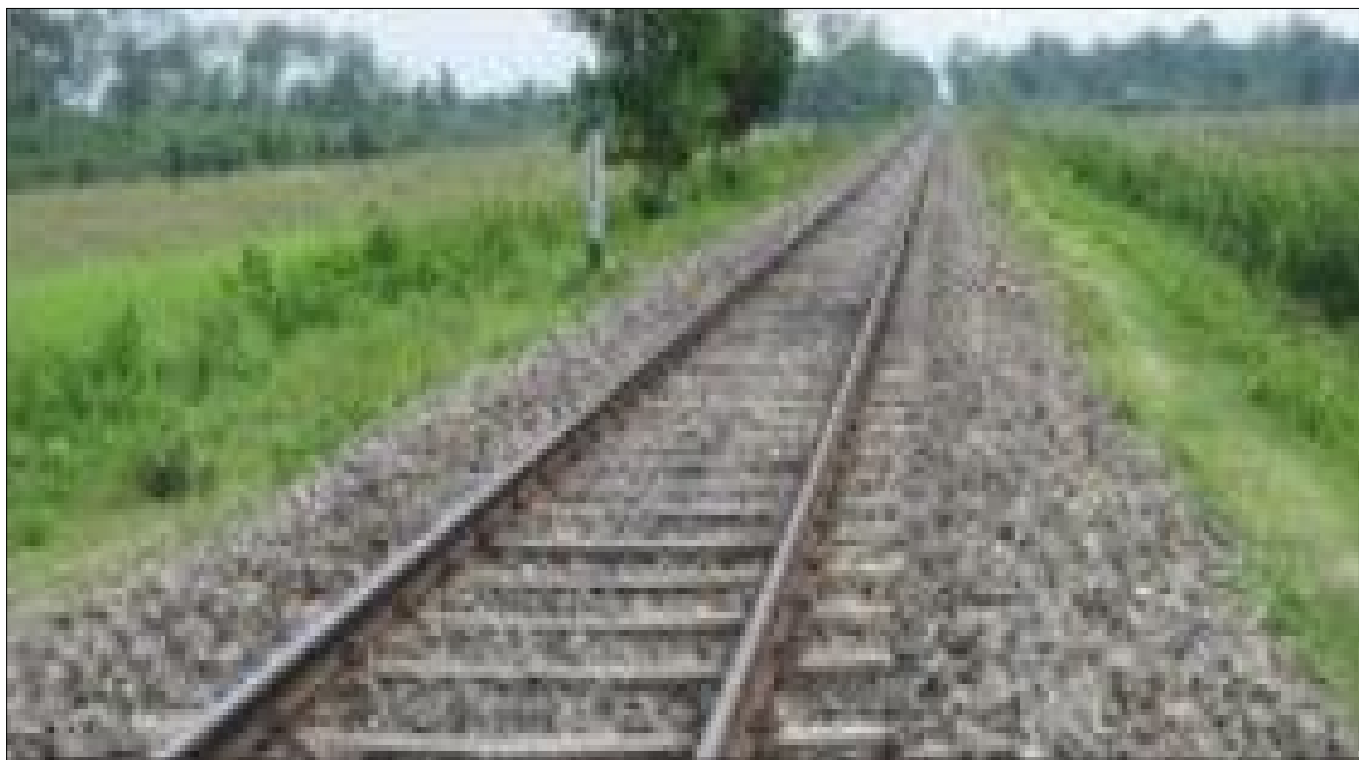
**Photo 11 : Condition of the track two years after rehabilitation (as on June 2008)**

Approximately two years has passed since the completion of the rehabilitation. As per the feedback from NF Railways, any significant ballast sinking problem has not been observed in the location treated with geogrids and geotextiles and there is an appreciable improvement in the track performance. Taking note of the success of this trial, NF Railways rehabilitated another stretch using the same materials and technique with satisfactory results. An inspection of the site in the first week of June 2008 showed that the condition of the treated portion of the track is quite satisfactory.
