Viche River (Poblado de Cube) Province of Esmeraldas - Ecuador

CCX-MAT™ (CCX-M™) Installed to prevent erosion to right bank of Viche River

In December 2021, CCX-M™ GCCM* was used to provide bank protection to the bank of the Viche River in Esmeraldas Province, Ecuador, to prevent water from reaching and undermining the nearby OCP and SOTE pipelines.

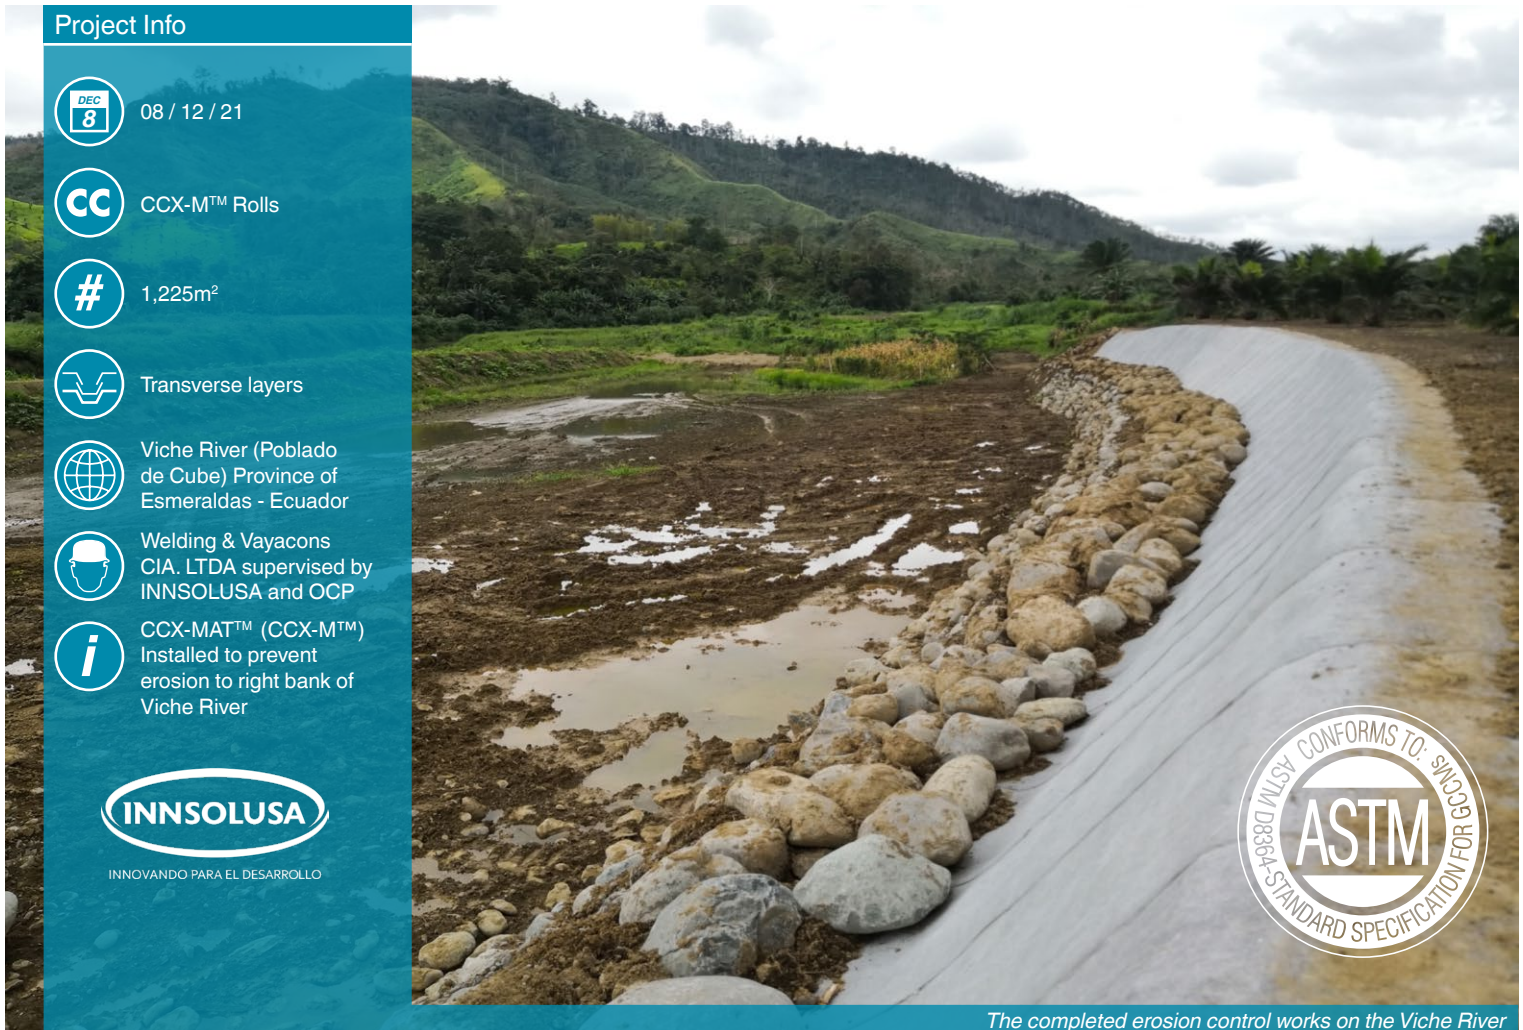
The completed erosion control works on the Viche River

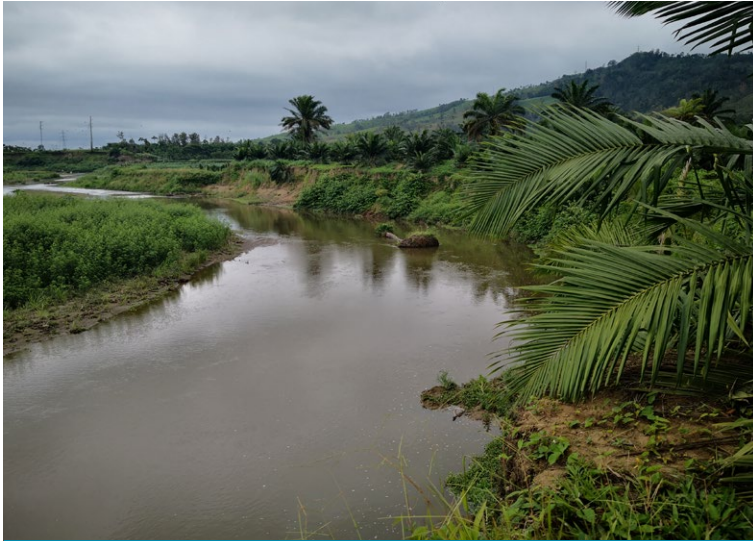
Riverbank before work commenced

The Viche River flows into the Esmeraldas River. Heavy winter rainfall in the catchment results in increased flows in the Esmeraldas river causing damming of the Viche River, resulting in flooding and erosion. With a measured erosion rate of 15.2m/year, it was predicted that the repeated flooding of the Viche river would reach the path of the pipelines within 3 years, risking an interruption of the crude oil transportation service at significant economic cost.

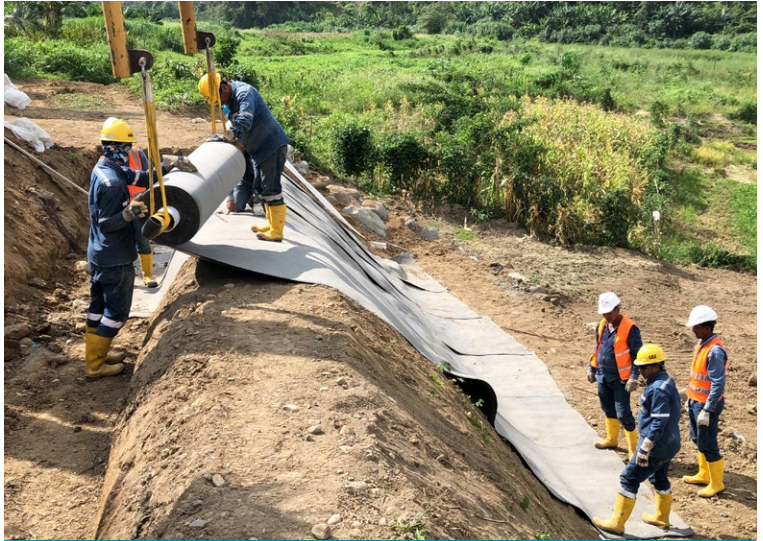
CCX-M™ installed with a boom and laid vertically

The CCX-MTM was installed with the aid of a boom truck and was unrolled and cut to the desired length by the operators. An anchor trench was excavated at the crest and toe of the slope into which the CCX-MTM was secured with 12mm thick steel pegs through each overlap. The subsequent layers of the CCX-MTM were overlapped by 100mm and joined using adhesive sealant, secured with 30mm stainless steel screws in two zigzag rows every 50mm. Once the installation was complete, the CCX-MTM was hydrated. Finally, the toe trench was covered with rock giving greater weight to the CCX-MTM anchorage and backfilled with earth.

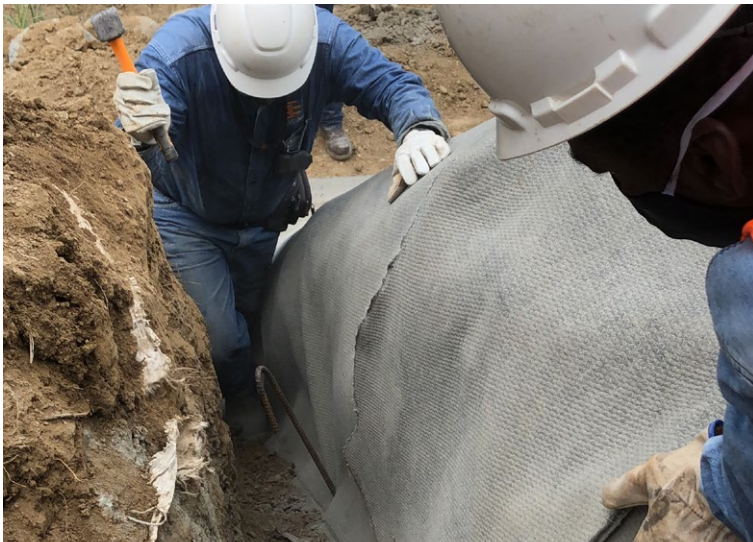
The edge of the CCX-M™ was pegged at the base of the anchor trench

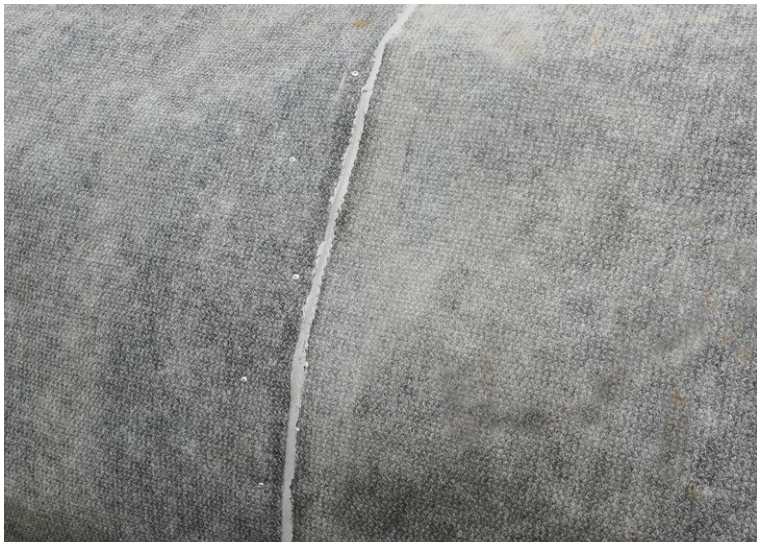
The CCX-M™ overlapped every 1.8m and secured with 30mm screws

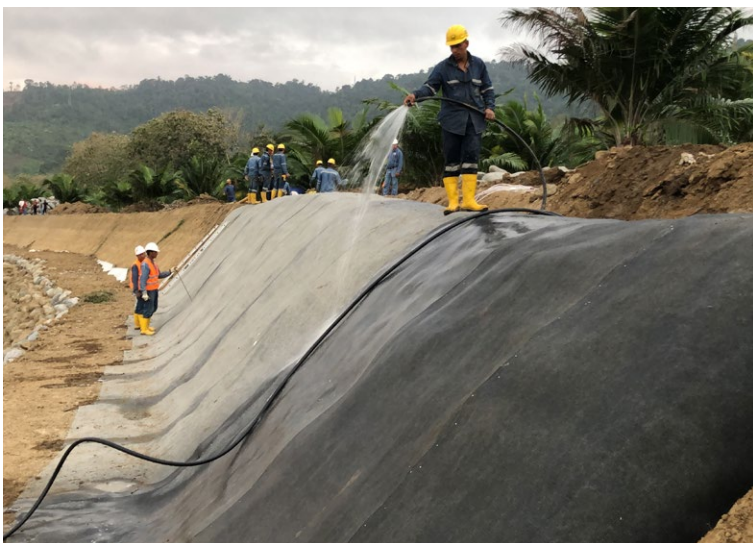
Once installation was complete, the CCX-M™ was hydrated

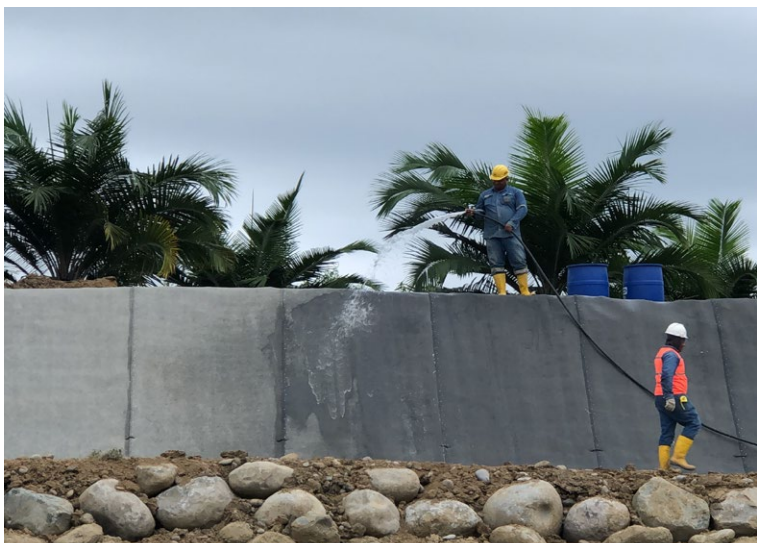
Hydration taking place

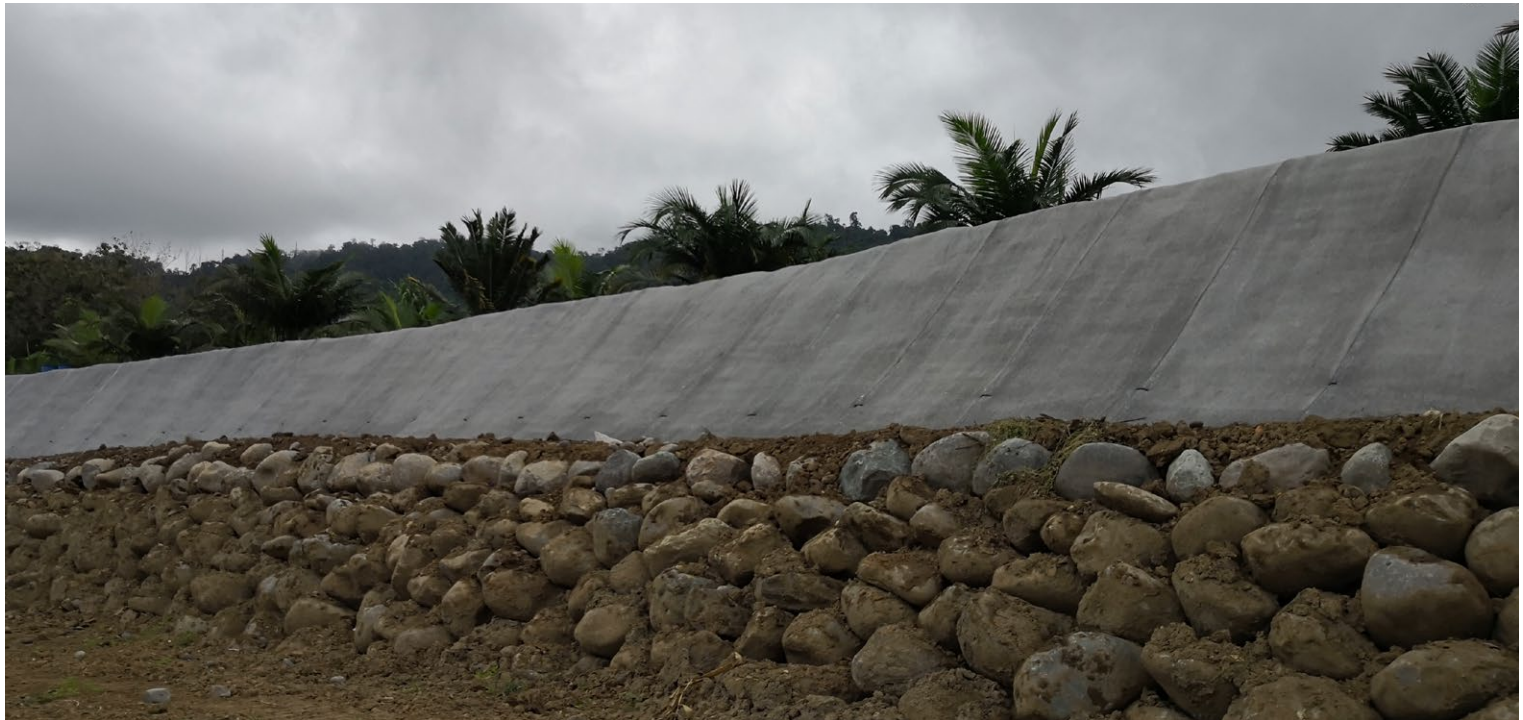
Completed erosion protection works

Prior to the CCX-MTM being installed, the contractor created a 2m deep breakwater foundation at the base of the riverbed, supporting a 56° slope constructed from 1.2–1.5m diameter rock. Above this a 45°, 6m long slope was profiled and lined with CCX-MTM to provide erosion protection from subsequent flooding.

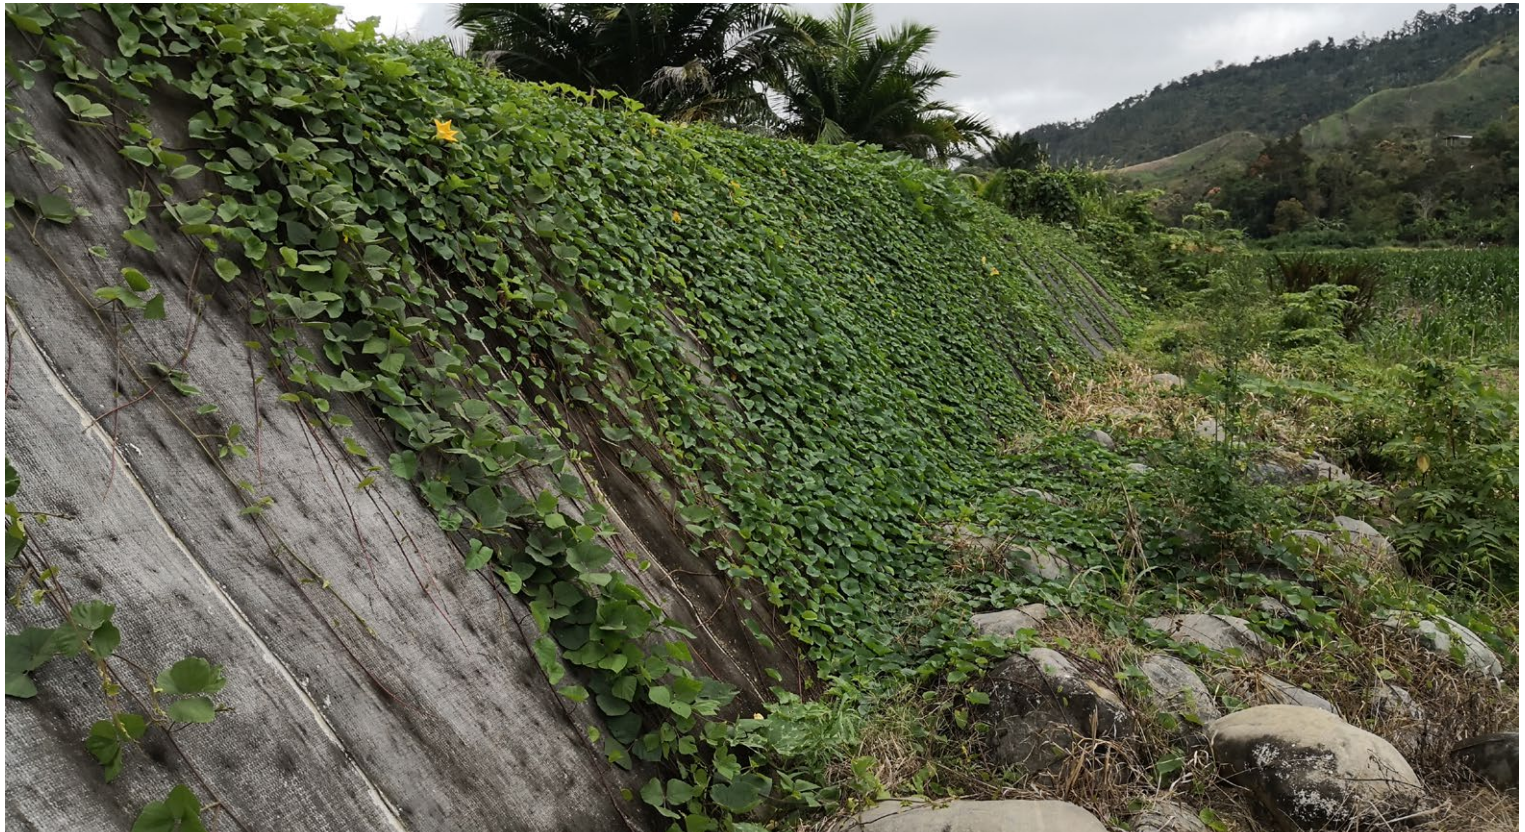
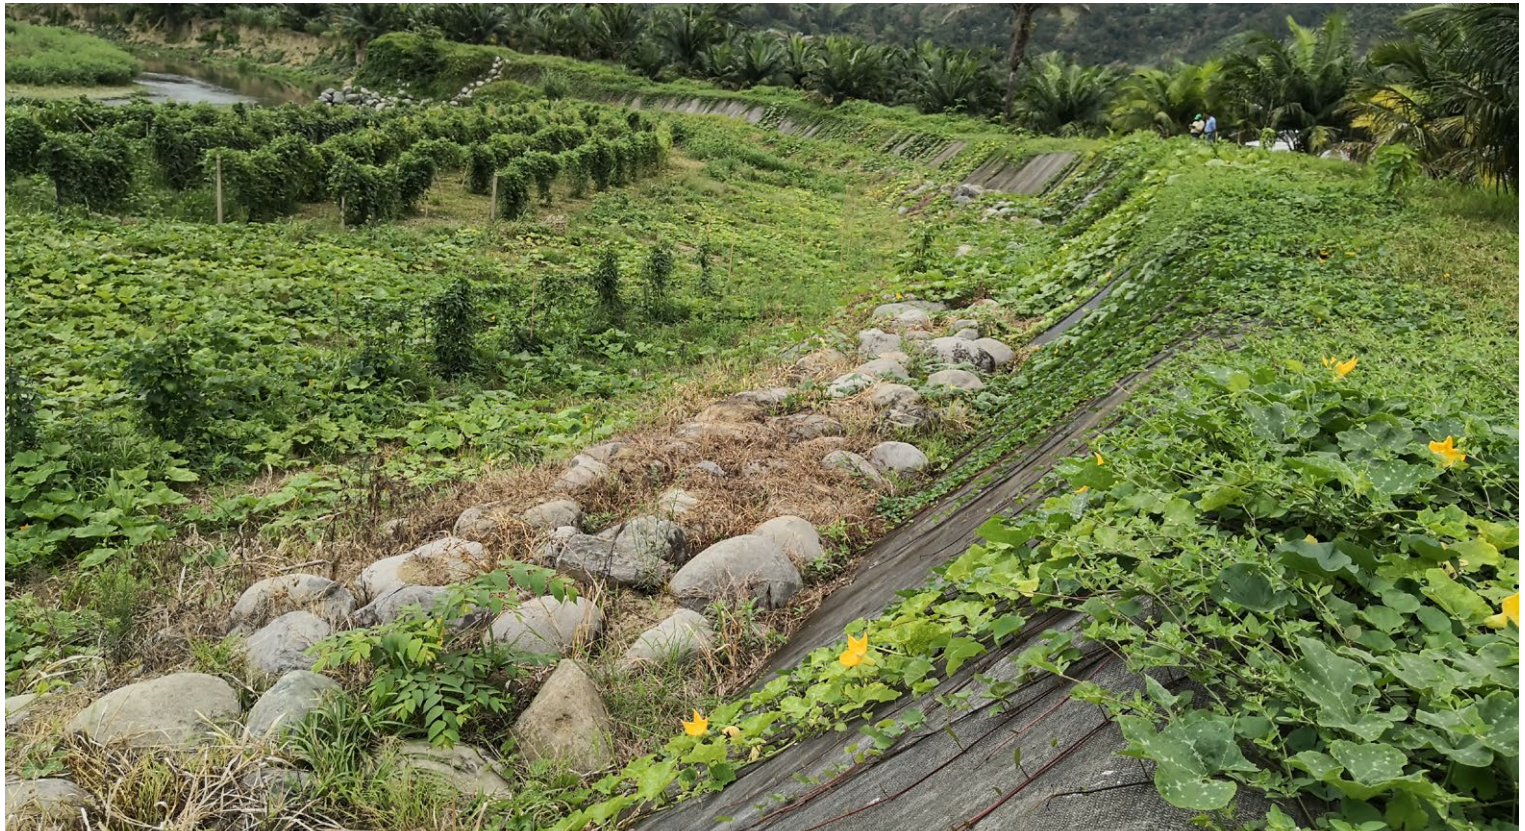
Vegetation growth at the toe and crest of the bank installaton, CCX-M™ is still performing as expected

During a site visit in September 2022, the installation was found to be in optimal condition, considering that it has resisted 4 floods since December 2021 and is now going into its second rain season.
