## CASE HISTORY

### ROCKFALL PROTECTION WORK AT JORABAT - SHILLONG SECTION OF NH-40 FROM KM. 0+000 TO KM. 61+800, ASSAM & MEGHALAYA

#### Rockfall Protection

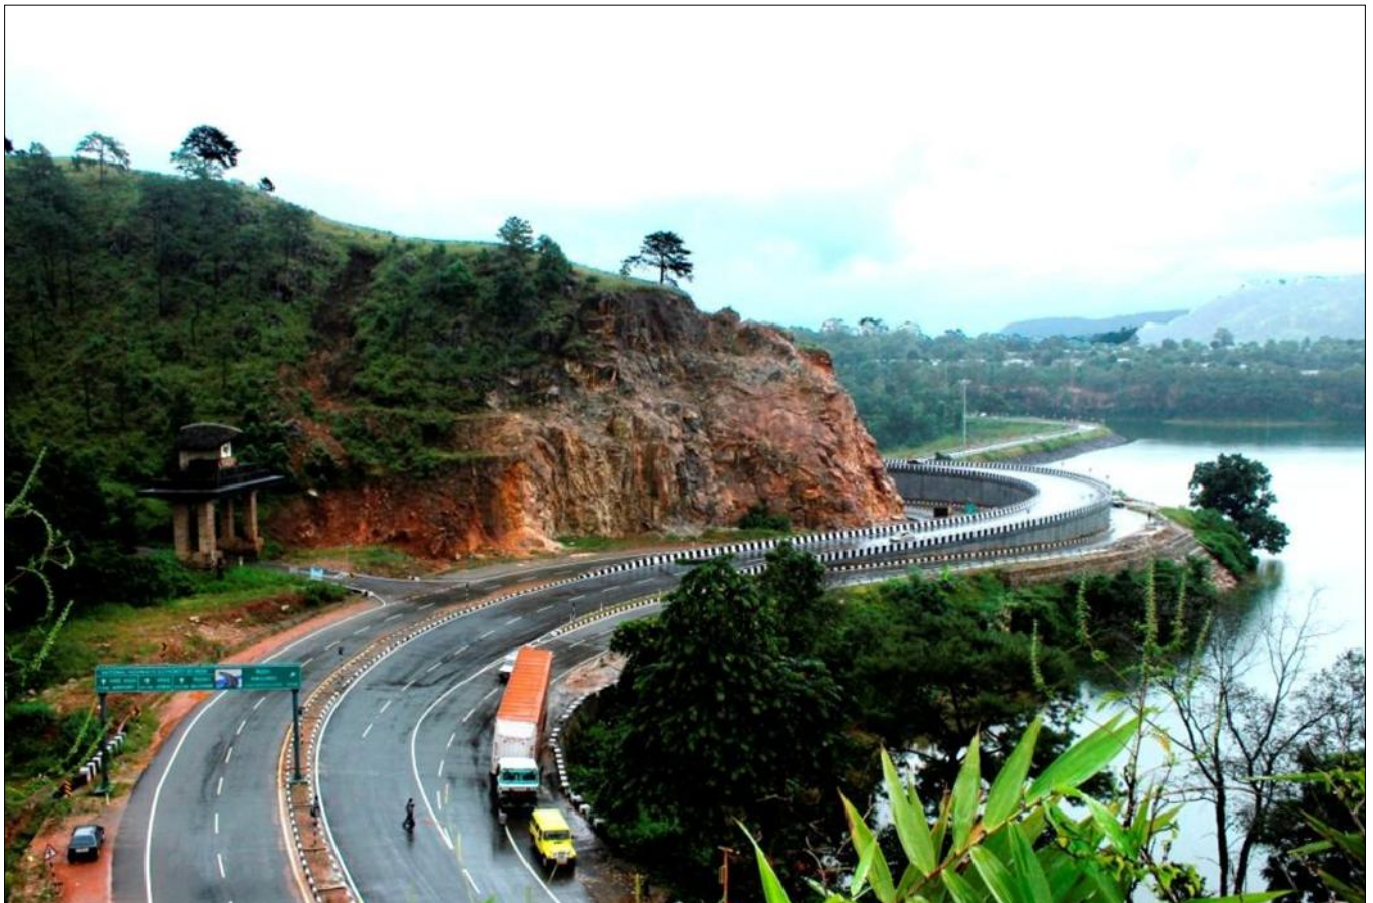
Before implementation of Rockfall Netting

Before giving solution, consultant visited the site. It was observed that the particular section was in cutting and the cutting has exposed rock faces that were intact in some locations and fragmented in few locations. The exposed rock surface on the sloping face is always subjected to disintegration by various causes such as plant action, thermal expansion, wind, freeze and thawing action of the pore water, hydrostatic pressures etc. The disintegration of parent rock leads to formation of rock pieces, boulders and debris and they easily detach from the bed rock and will slide over the slope. Such fall of rock happens catastrophically at random locations without giving prior warning. During monsoon seasons, the situation gets worsen that rock falls may become vary frequent. This called for rockfall protection solutions.

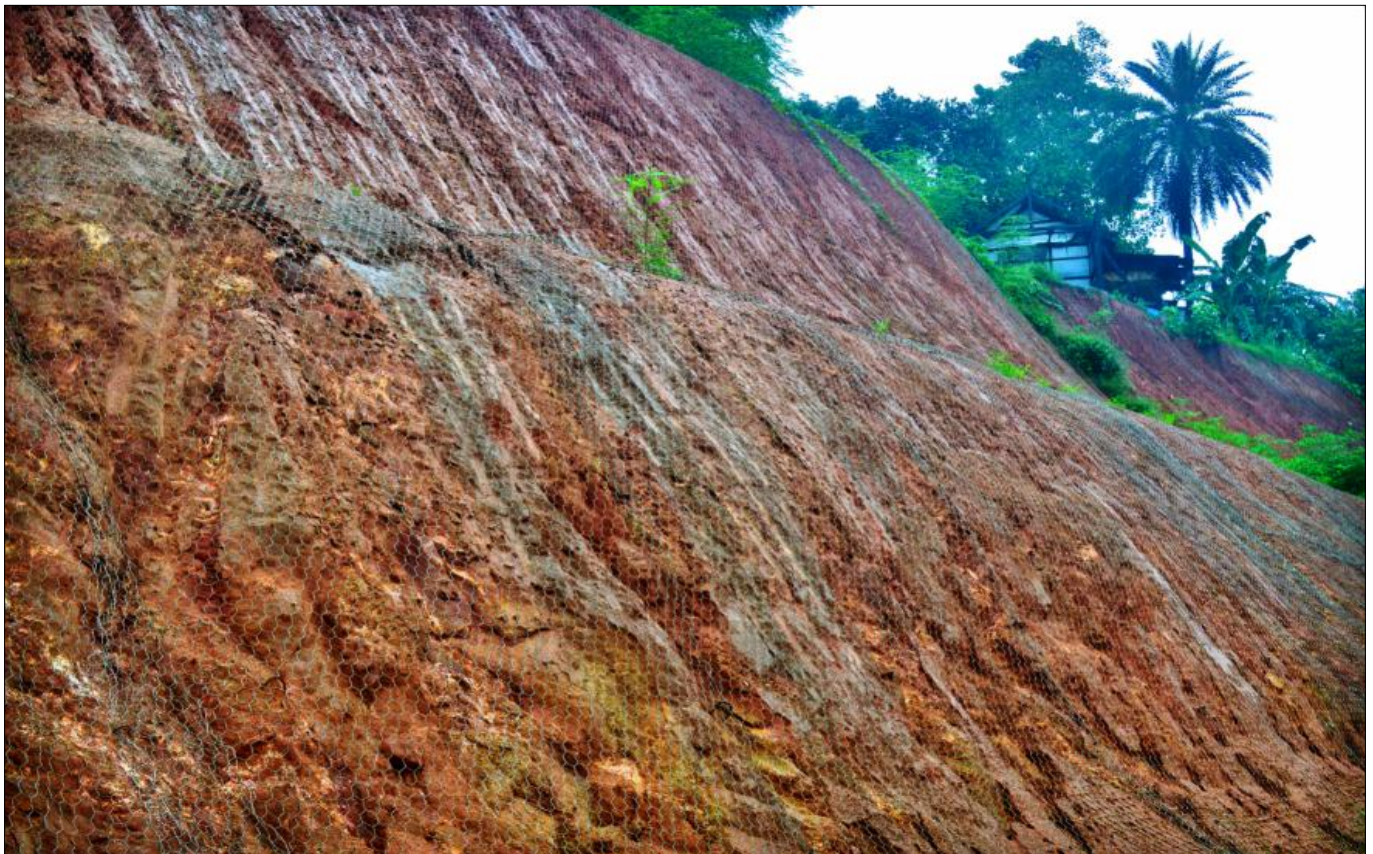
Slope after installation of Rockfall Netting

To prevent the rockfall from the side hill slopes on to the road, TechFab india suggested Rockfall Netting with special 5.5 Twisted Zinc + PVC coated wire mesh with Mesh type ( 8x10) along the slope and it was anchored by using raised anchorage system at top and bottom.

The height of cutting to be protected was 6m to 15m. The slope angle of cut section is varying from 55° to 70°. The rockfall protection system will prevent the fall of any rock pieces directly on road and it will guide the boulder to fall at toe of the hill slope and hold the disintegrated rocks, where the bottom anchors are placed.

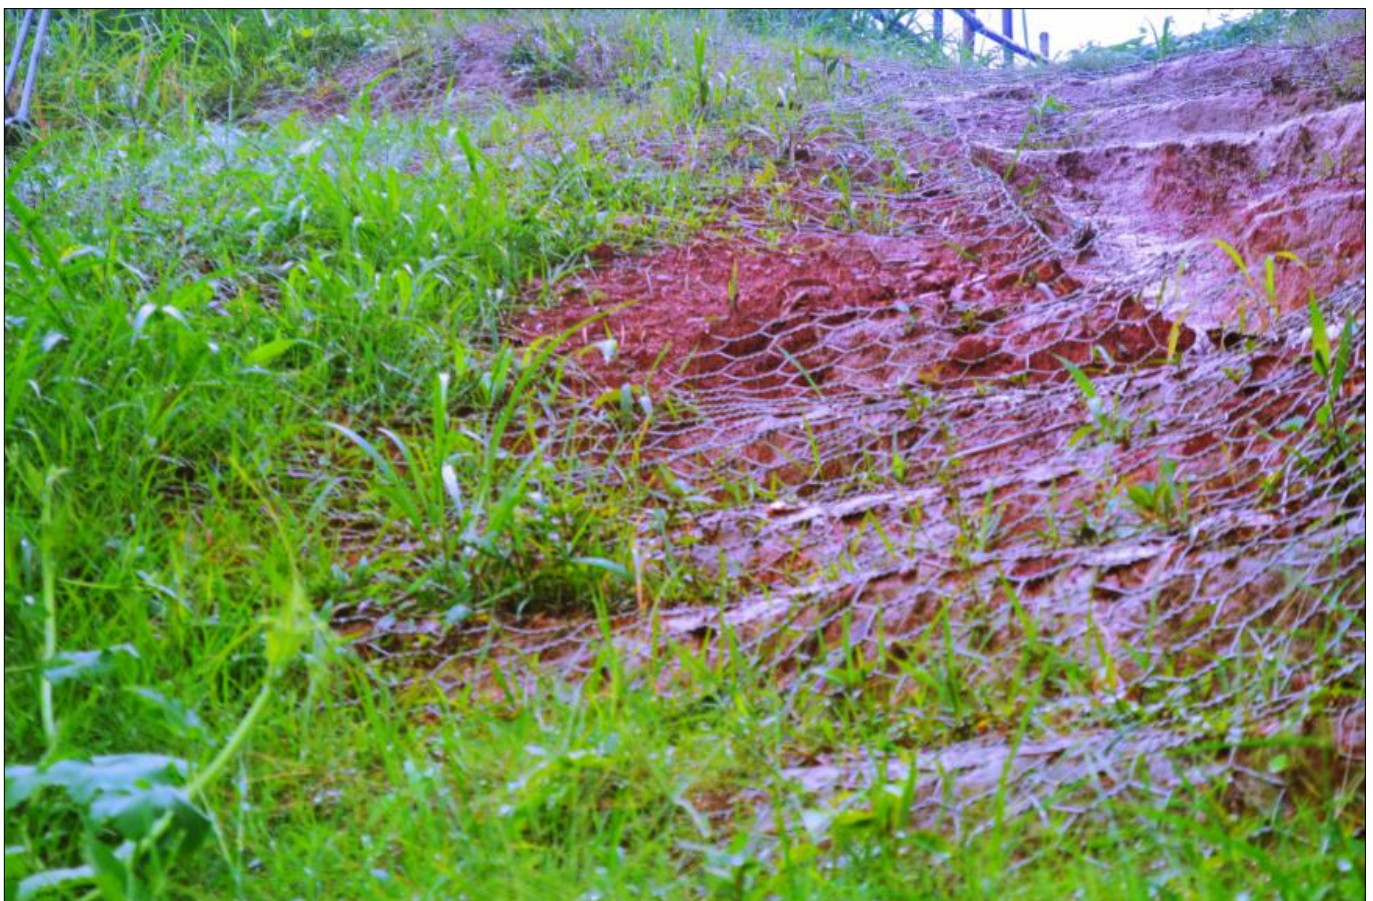
Top of Slope after Vegetation has grown

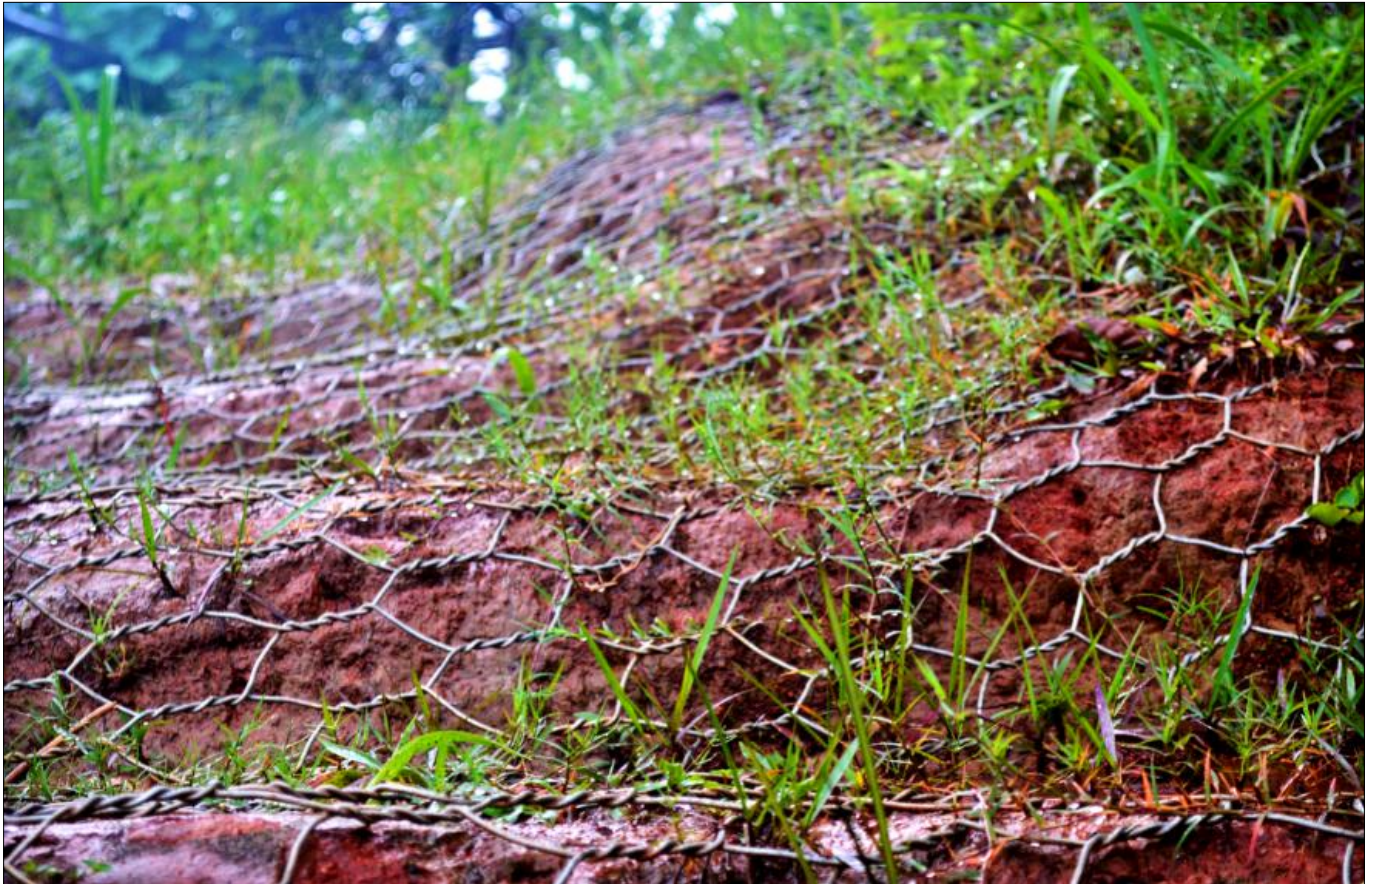
Top of Slope after Vegetation has grown

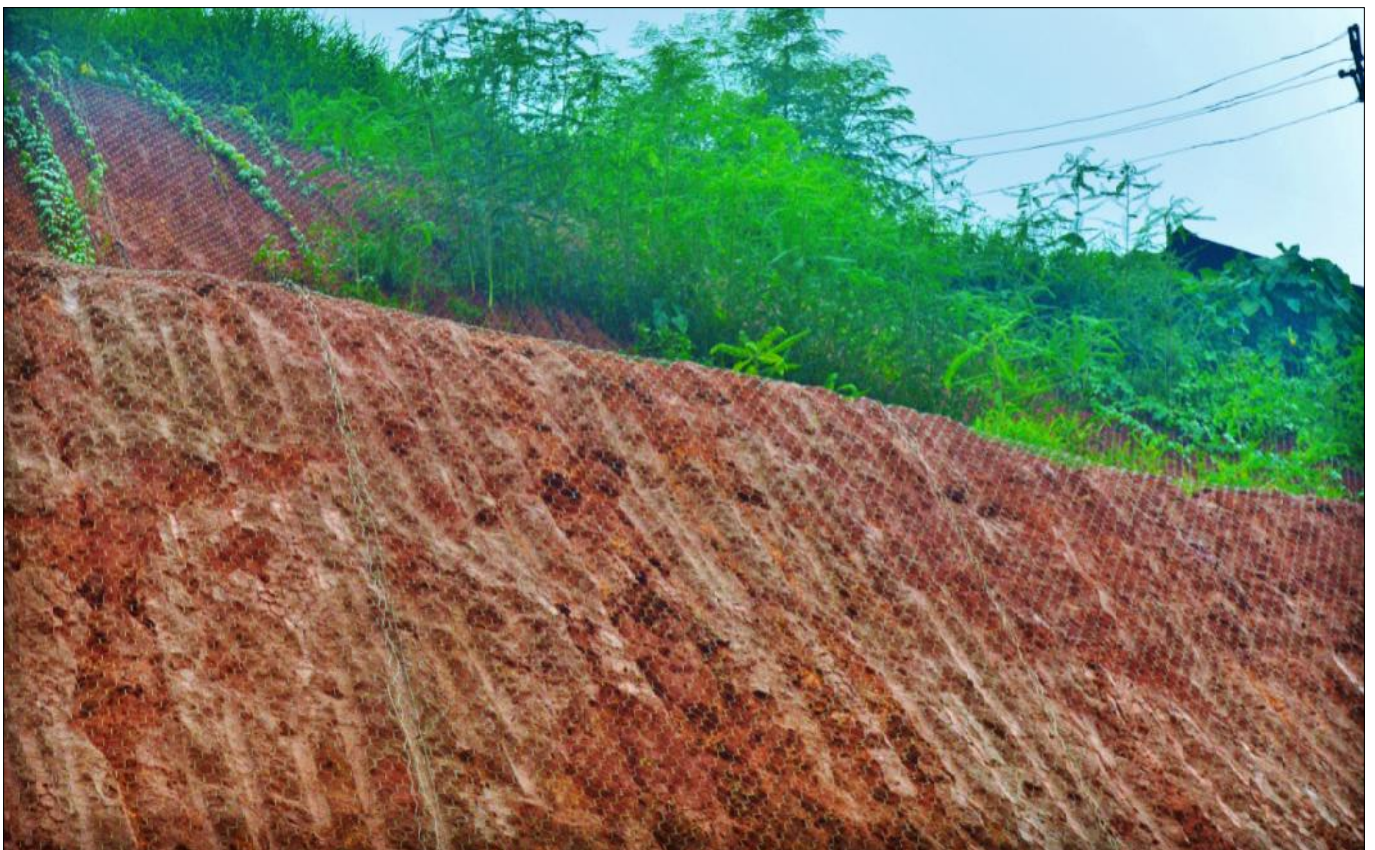
Slope after installation of Rockfall Netting

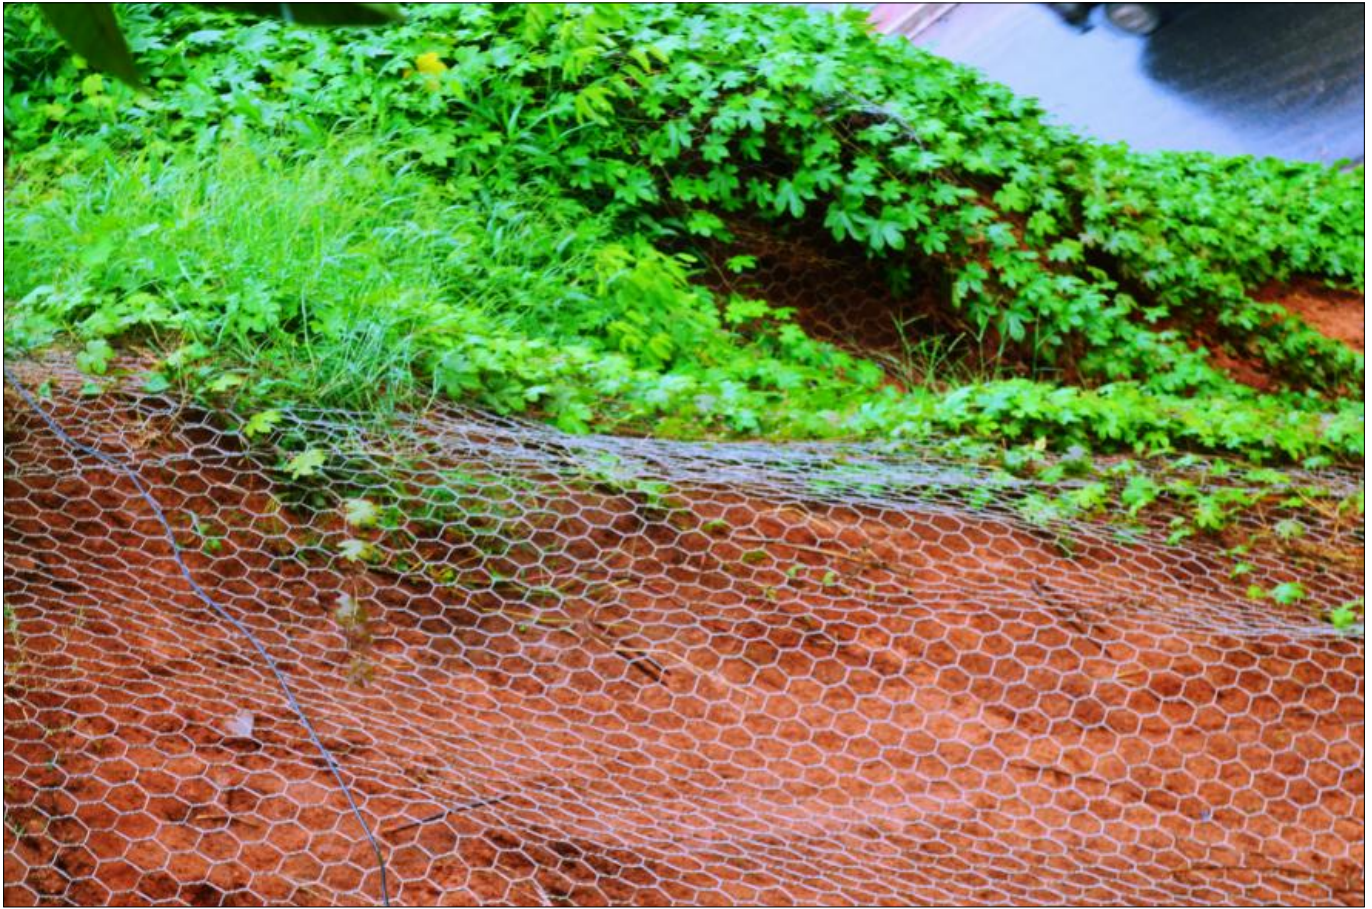
Structure after 7 years

It has been 7 years since project is completed. Rock fall protection system faced many worst monsoons still and the system is working as per the project requirement and desired by the client.
