## CASE HISTORY

### LANDSLIDE MITIGATION MEASURES FOR TAMENGLONG - MAHAR NATIONAL HIGHWAY (NH-137) IN ASSAM

DIMA HASAO, ASSAM, INDIA

#### **Slope Protection**

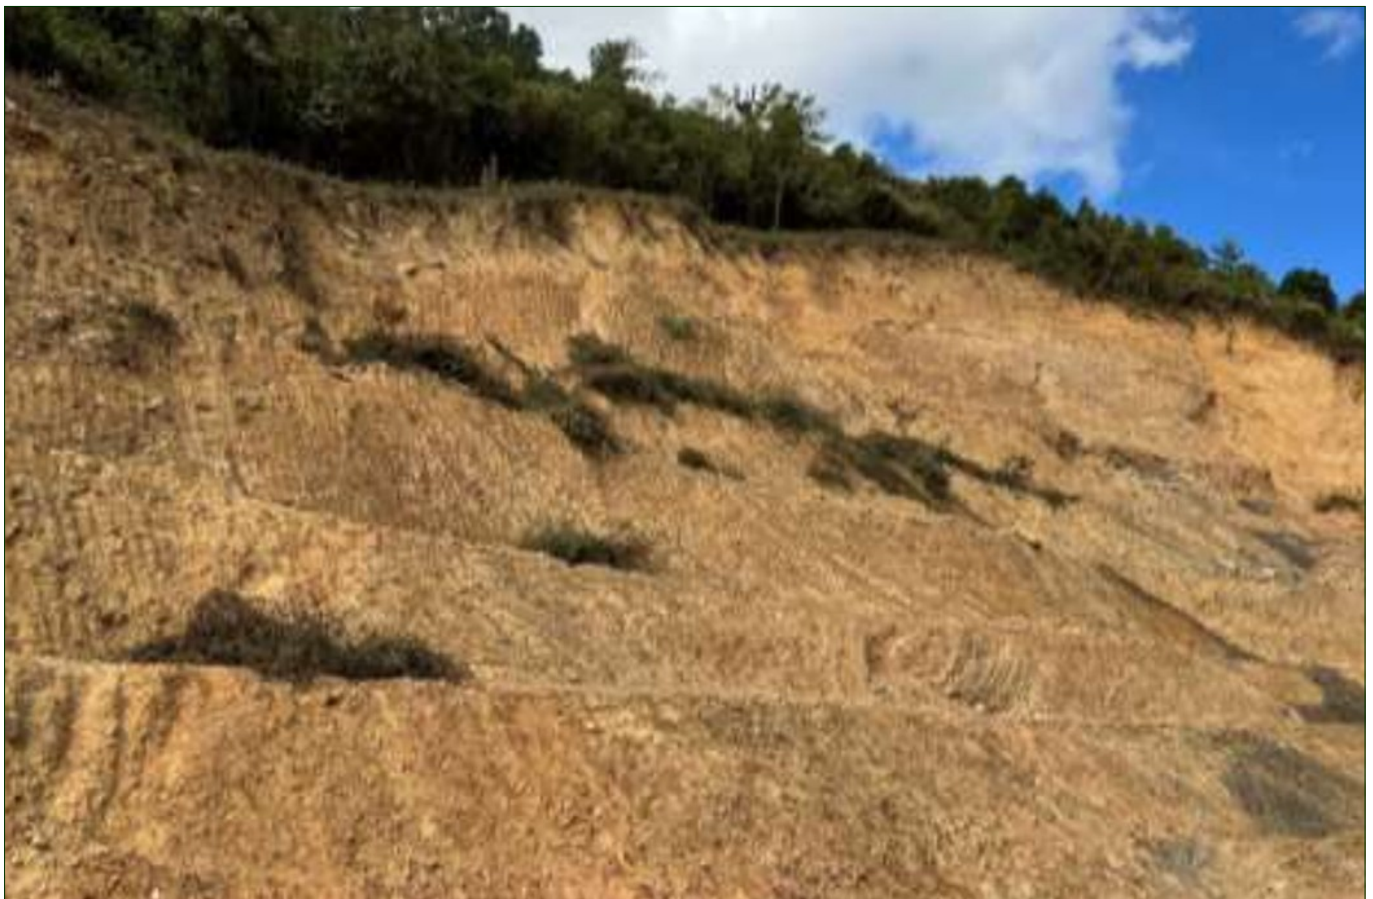
**Photo 1 : Exposed Hill-side cut slope with overburden strata over weathered rock along package 8**

During the road widening of NH-137 from Tamenglong to Mahur, extensive hill-side cutting, along with the removal of vegetation and topsoil, was carried out to achieve the desired road width. This process exposed fragile geological formations comprising weathered rocks and loose overburden materials, significantly disturbing the natural slope equilibrium.

The exposed surfaces were subjected to intense monsoonal rainfall and weathering effects, leading to increased pore water pressure, higher surface runoff, and reduction in the spacing of discontinuities. These factors reduced the shear strength of the slope materials (soil and rock), triggering both shallow and deep-seated failures along the hill slopes.

The complexity of the terrain, coupled with geological and climatic vulnerabilities, made slope protection a critical requirement in both Package-8 and Package-9. Photographs 1 and 2 illustrate the site conditions during initial investigations, highlighting exposed overburden, weathered rock formations, and visible slope instabilities.

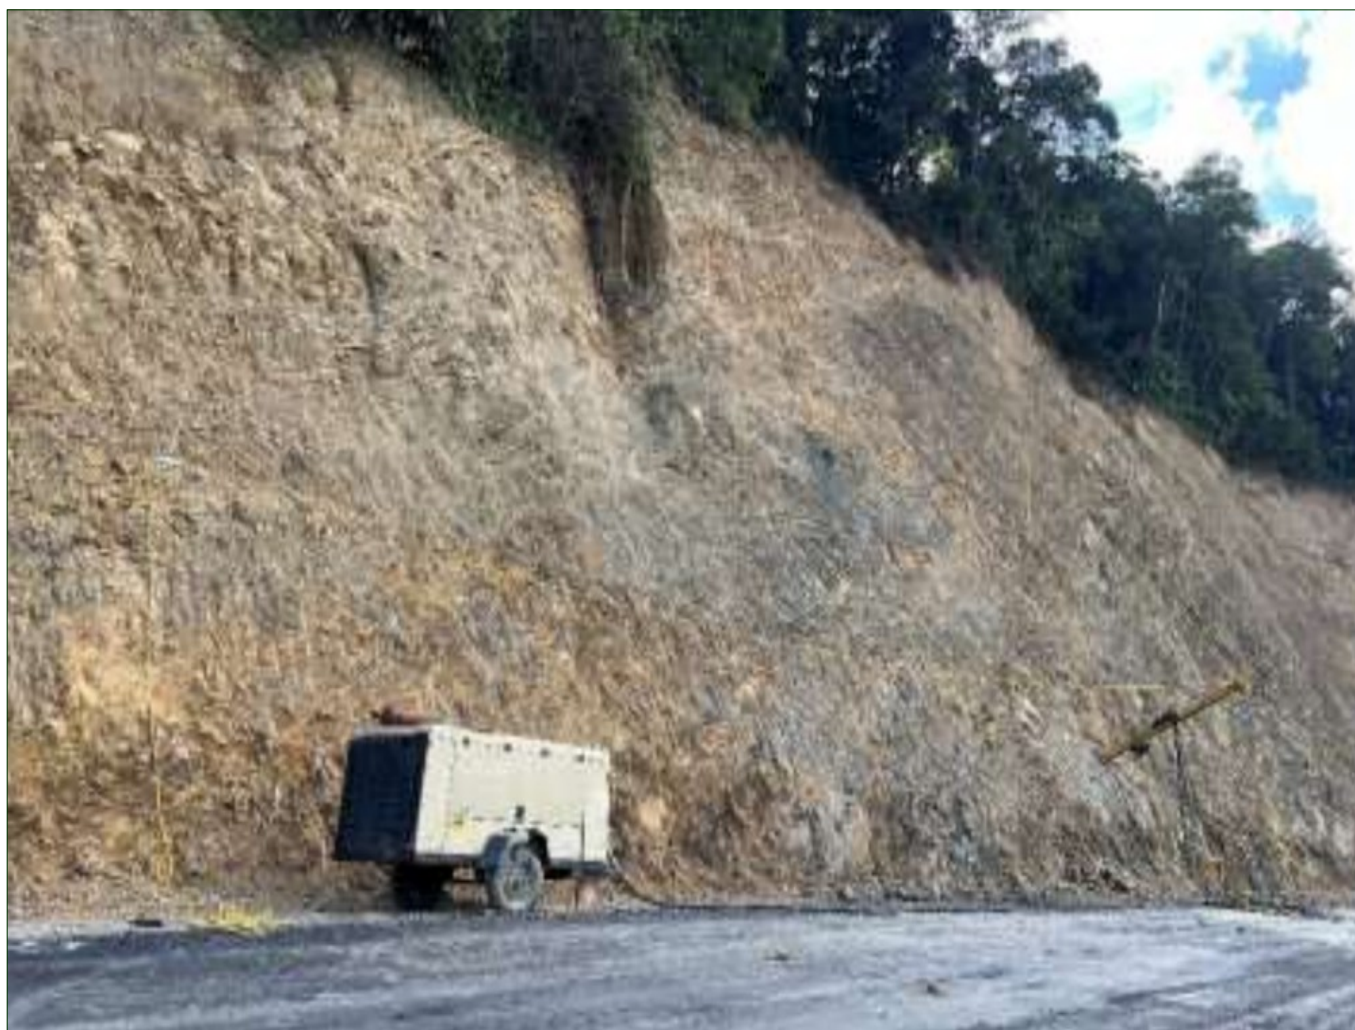
**Photo 2 : Exposed Hill-side cut slope having weathered rock along package 9**

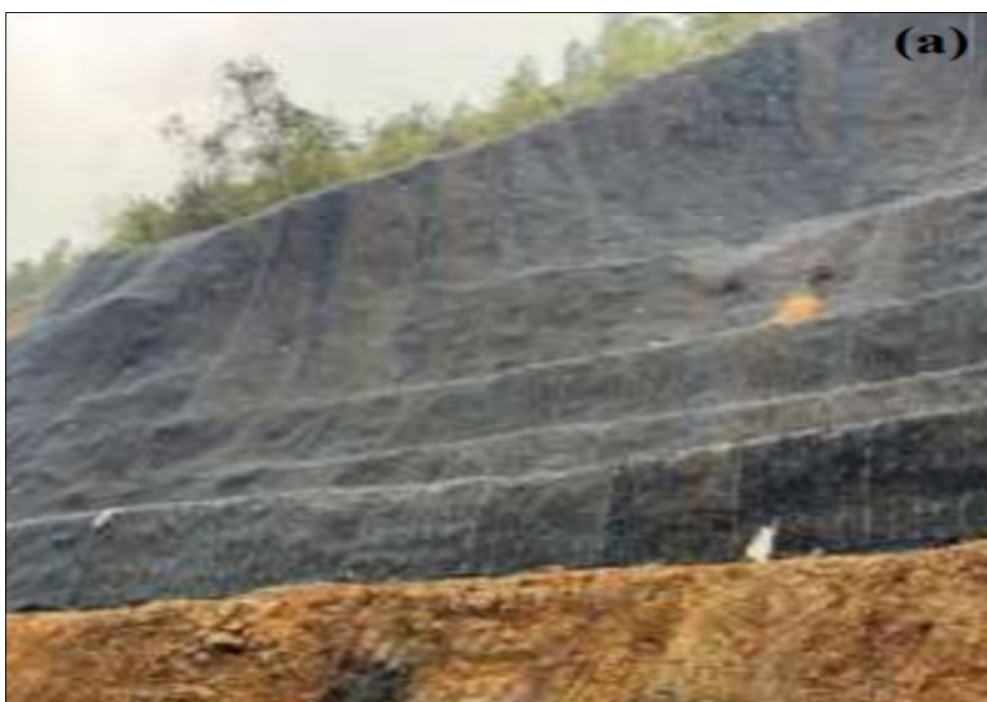
Photo 3 : During Construction Photograph

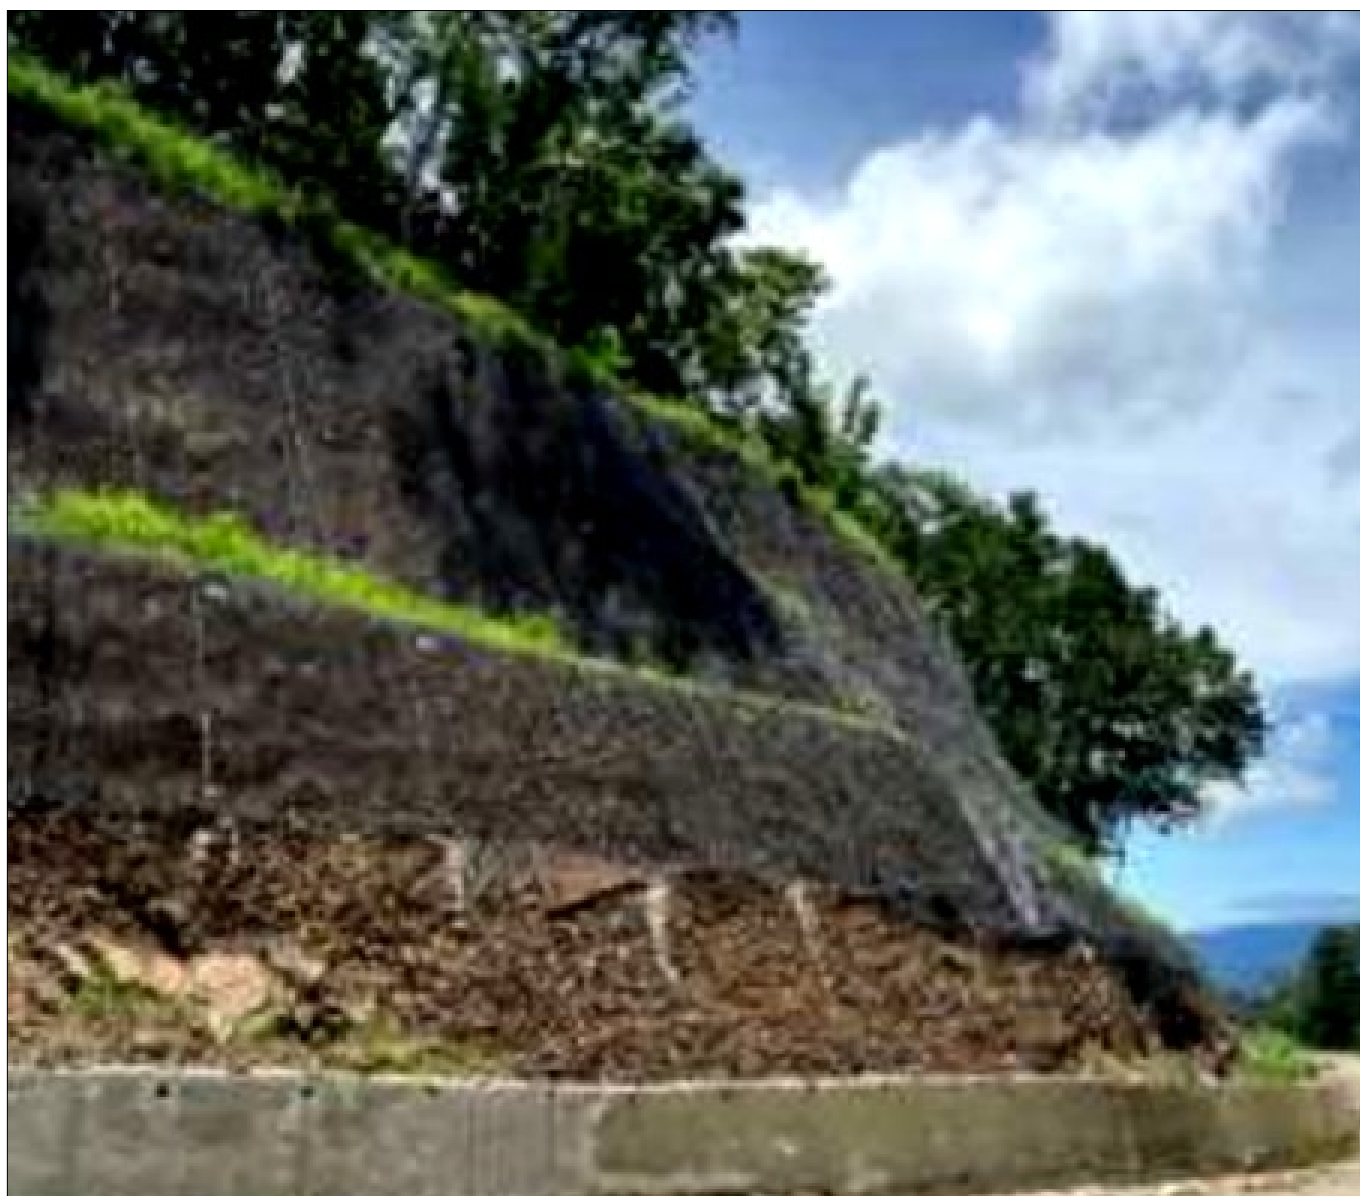
**Photo 4 : Completed Structure**
