## CASE HISTORY

**PAVEMENT STRENGTHENING IN SUMAN NAGAR, PRIYADARSHANI CIRCLE,  
CHEMBUR, MUMBAI, MAHARASHTRA**  
MUMBAI, MAHARASHTRA, INDIA

### **Pavement Stabilization**

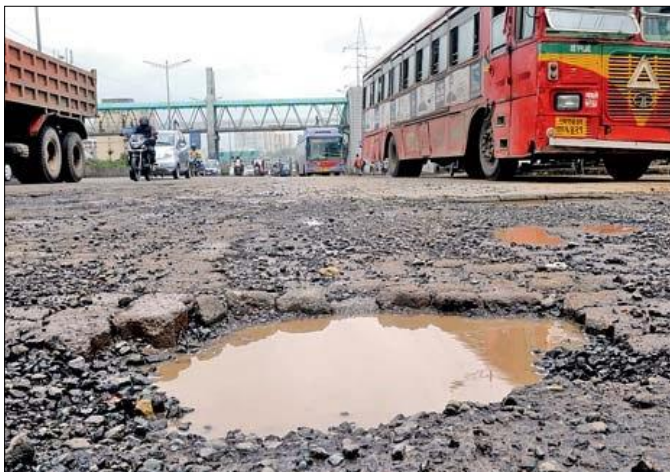
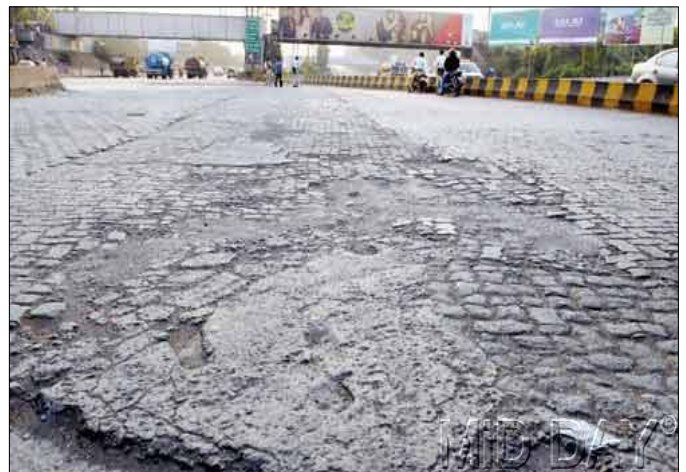
Rapid failures of Suman Nagar, Chembur stretch were identified to be a combination of certain factors mentioned as - incorrect sand bedding thickness and deficient compaction of the paving block layer. These constructional defects ultimately caused shear and differential settlements in the sand bedding layer and subsequent water infiltration into the pavement and overstressing of the cement stabilized sub base layers.

The poor draining characteristics of the bedding sand, as used, would trap water that permeated into the bedding layer, thereby aggravating the shear failure risk. The combination of stagnant water on the road surface along with heavy traffic could quickly cause erosion of the road surface. Secondly, the surface water was penetrating into the road body, reducing the load bearing capacity of the pavement, which was causing further damage to the road. Drainage of the road surface is normally provided by shaping the carriageway with a camber. The client therefore wanted an innovative method so that the solution adopted next would be a long term solution.

**Initial Condition of Road**

As the solution wanted by the client was a long term one, Techfab India Industries Limited suggested the application of TechGlass. TechGlass provides various advantages such as this would restrict reflective cracking, prevent water and tear, gives long term strength to the pavement. Being a heavy traffic stretch, some parts of pavement had severe undulations and drain water was flowing towards the road and not out, due to the wrongly placed camber. The existing surface was cleaned and made dust, debris free, and free from obstacles. Then tack coat was sprayed over which TechGlass was laid.

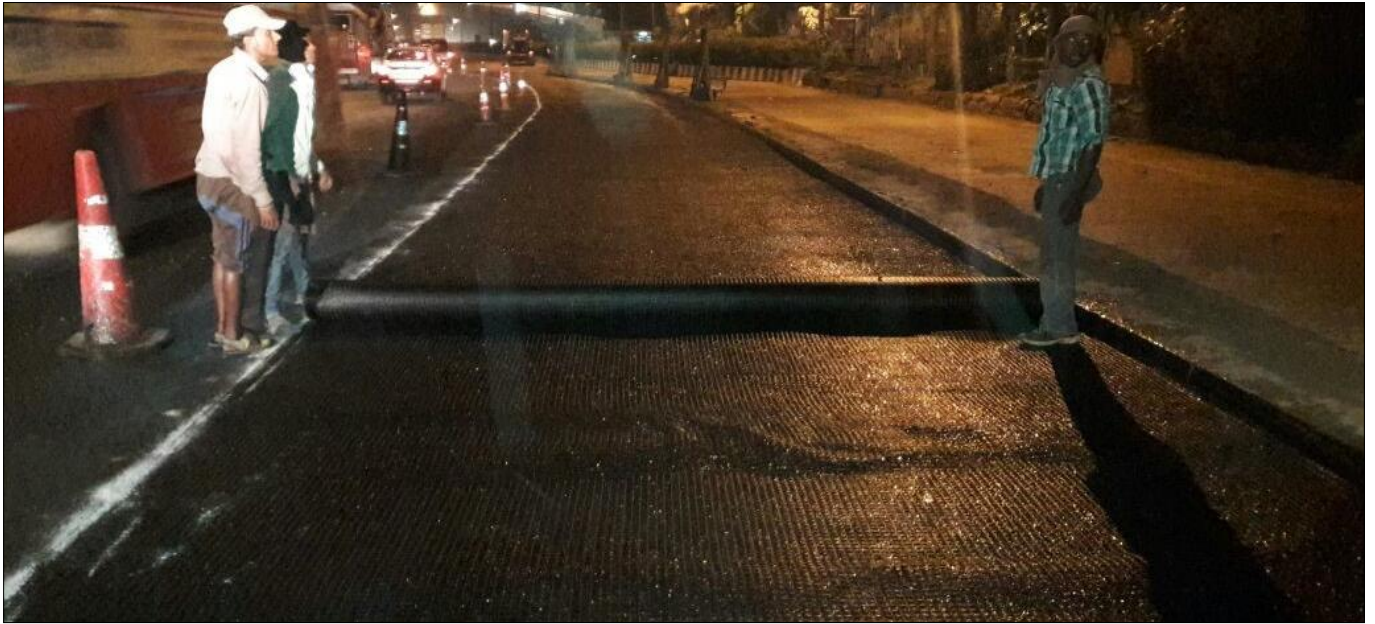
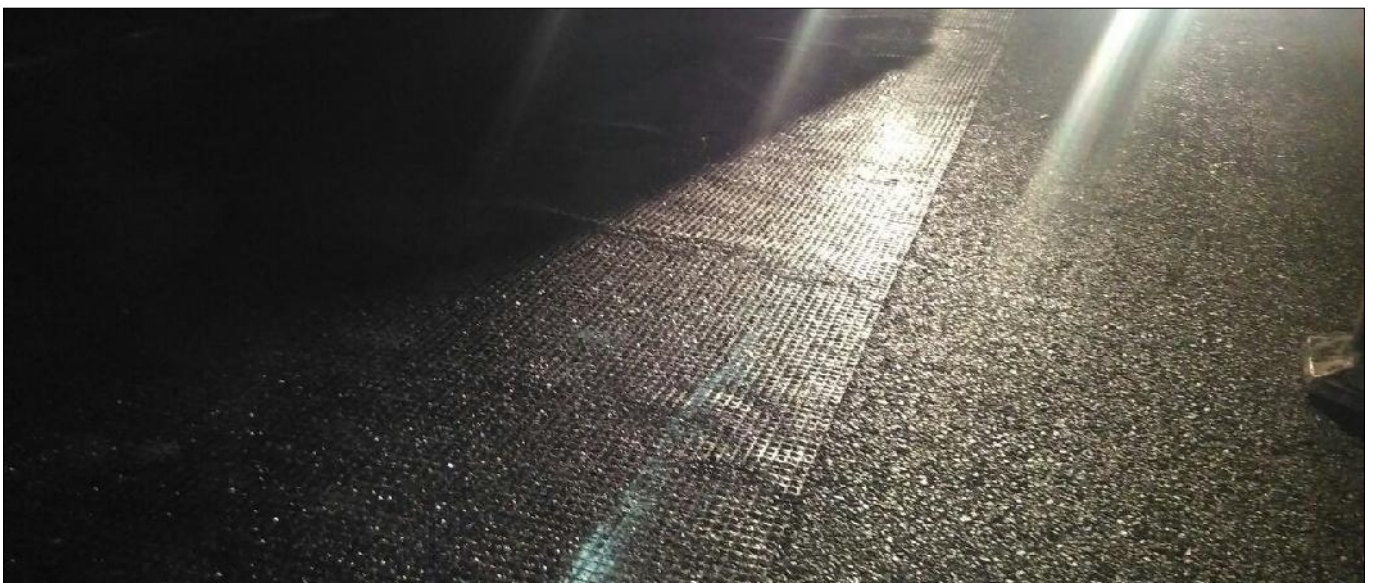
Most of the work was conducted at night, as the traffic was not interrupted. Over the TechGlass, Asphalt layer was laid and then compacted properly.

During Construction Photographs
