## CASE HISTORY

### ROCKFALL PROTECTION WORK AT JORABAT - SHILLONG SECTION OF NH-40 FROM KM. 0+000 TO KM. 61+800, ASSAM & MEGHALAYA

#### Rockfall Protection

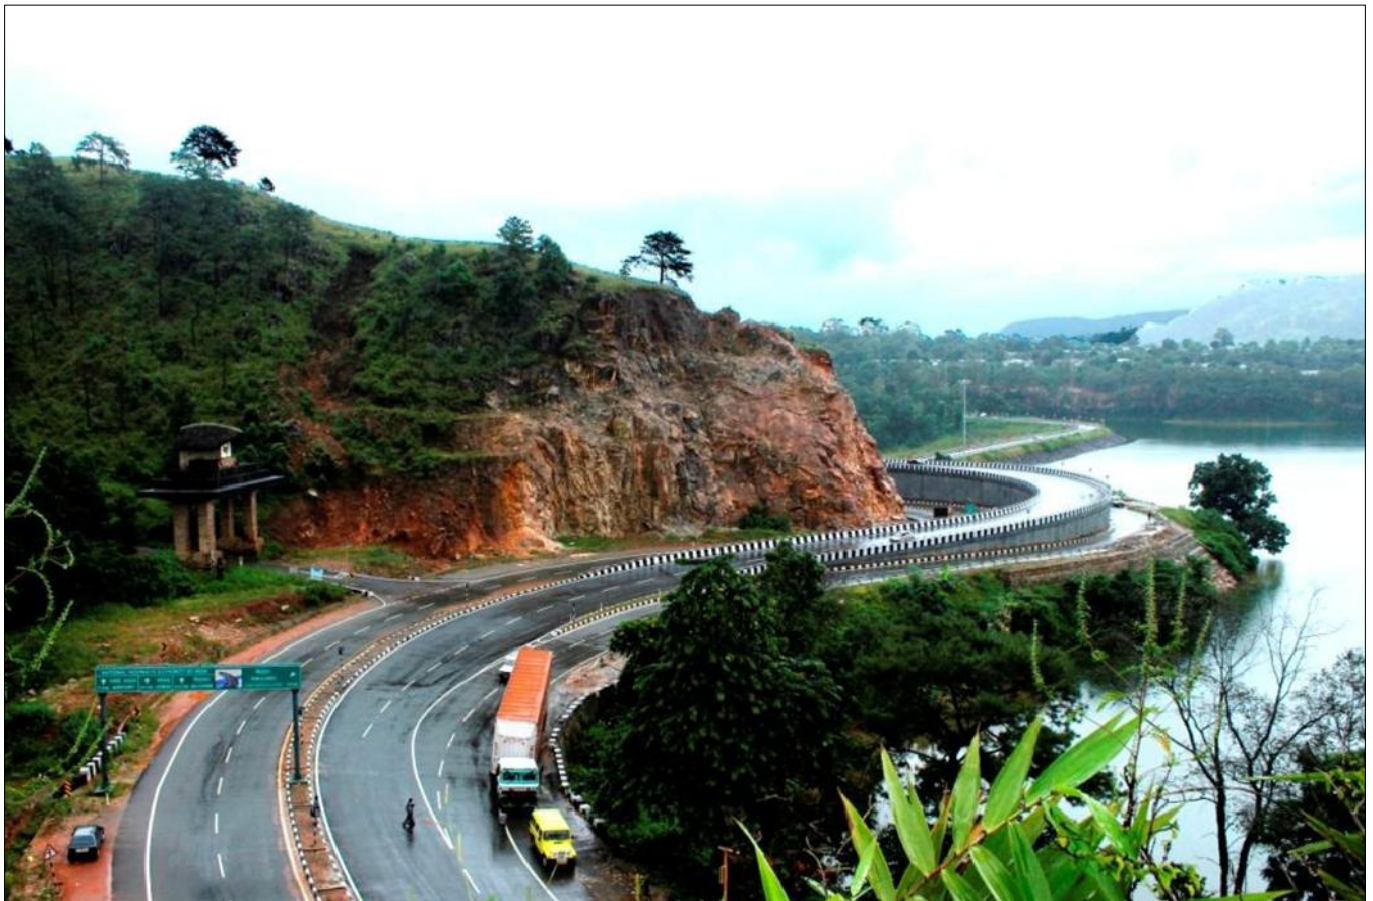
Before implementation of Rockfall Netting

Before giving solution, consultant visited the site. It was observed that the particular section was in cutting and the cutting has exposed rock faces that were intact in some locations and fragmented in few locations. The exposed rock surface on the sloping face is always subjected to disintegration by various causes such as plant action, thermal expansion, wind, freeze and thawing action of the pore water, hydrostatic pressures etc. The disintegration of parent rock leads to formation of rock pieces, boulders and debris and they easily detach from the bed rock and will slide over the slope. Such fall of rock happens catastrophically at random locations without giving prior warning. During monsoon seasons, the situation gets worsen that rock falls may become vary frequent. This called for rockfall protection solutions.

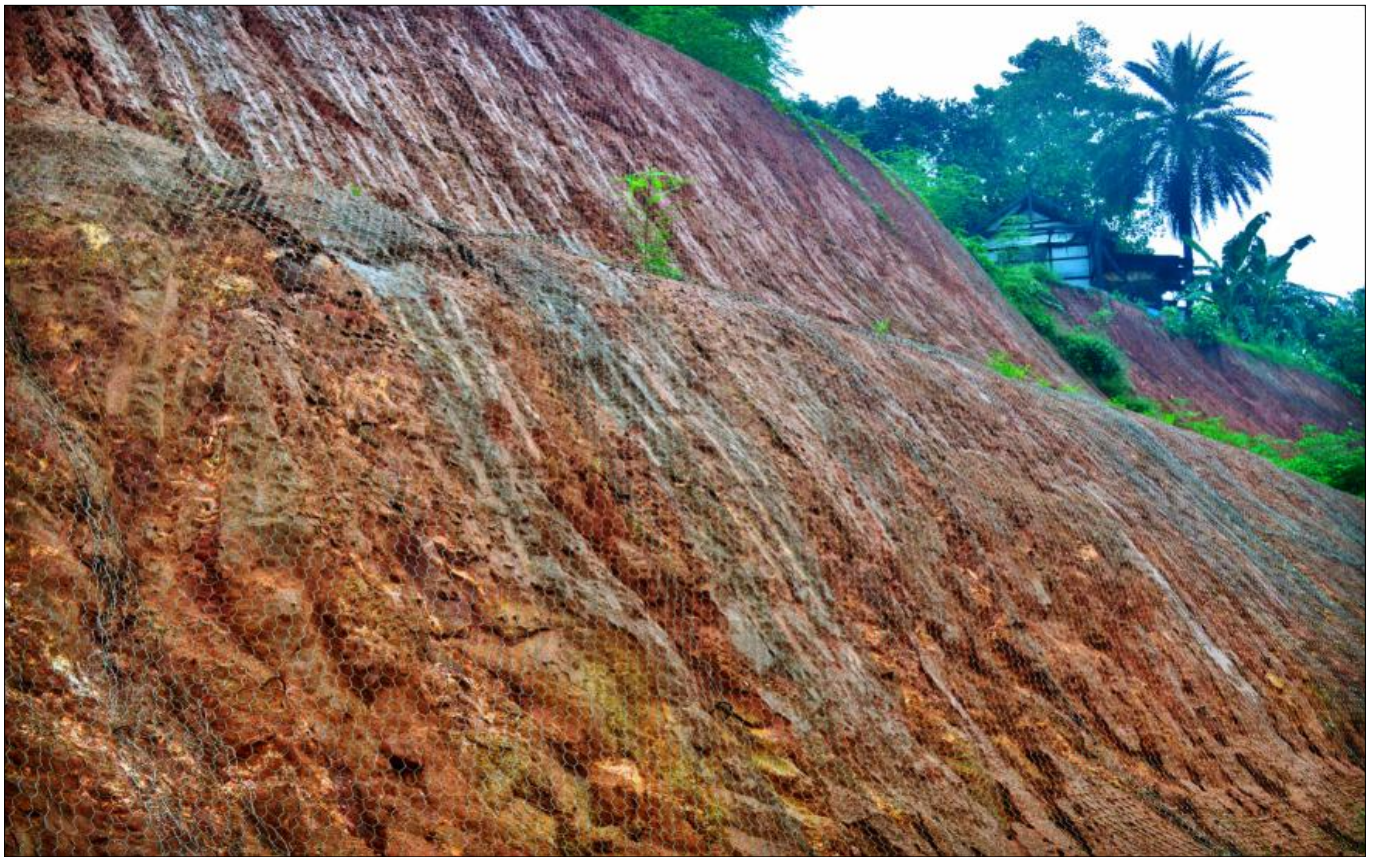
**Slope after installation of Rockfall Netting**

To prevent the rockfall from the side hill slopes on to the road, TechFab india suggested Rockfall Netting with special 5.5 Twisted Zinc + PVC coated wire mesh with Mesh type ( 8x10) along the slope and it was anchored by using raised anchorage system at top and bottom.

The height of cutting to be protected was 6m to 15m. The slope angle of cut section is varying from 55° to 70°. The rockfall protection system will prevent the fall of any rock pieces directly on road and it will guide the boulder to fall at toe of the hill slope and hold the disintegrated rocks, where the bottom anchors are placed.

The special 5.5 twisted wire mesh is made of Heavily Galvanized steel wires with PVC coating. The twisting is done mechanically and is non-raveling in nature.

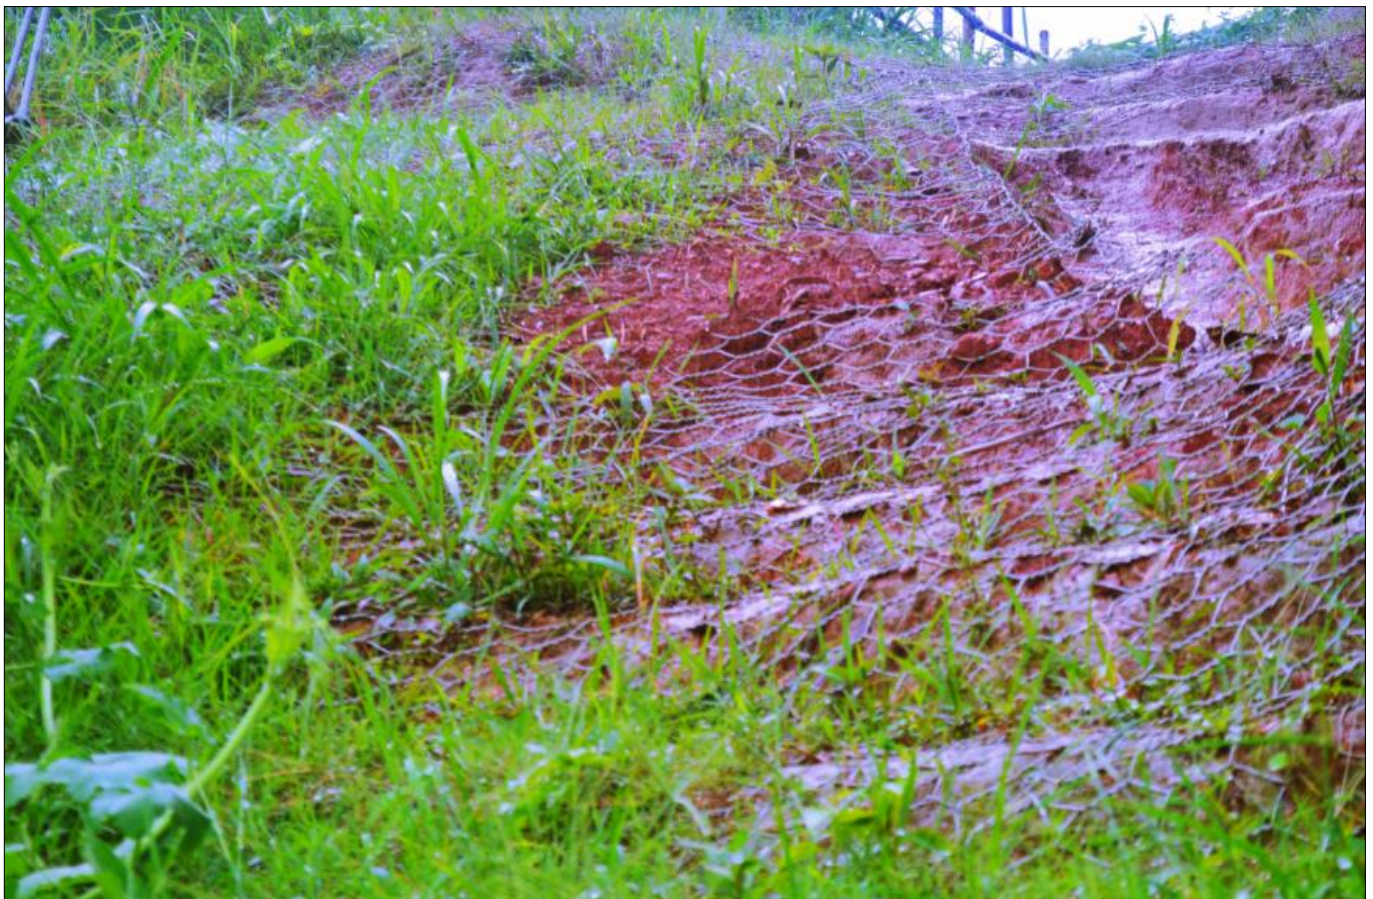
Top of Slope after Vegetation has grown

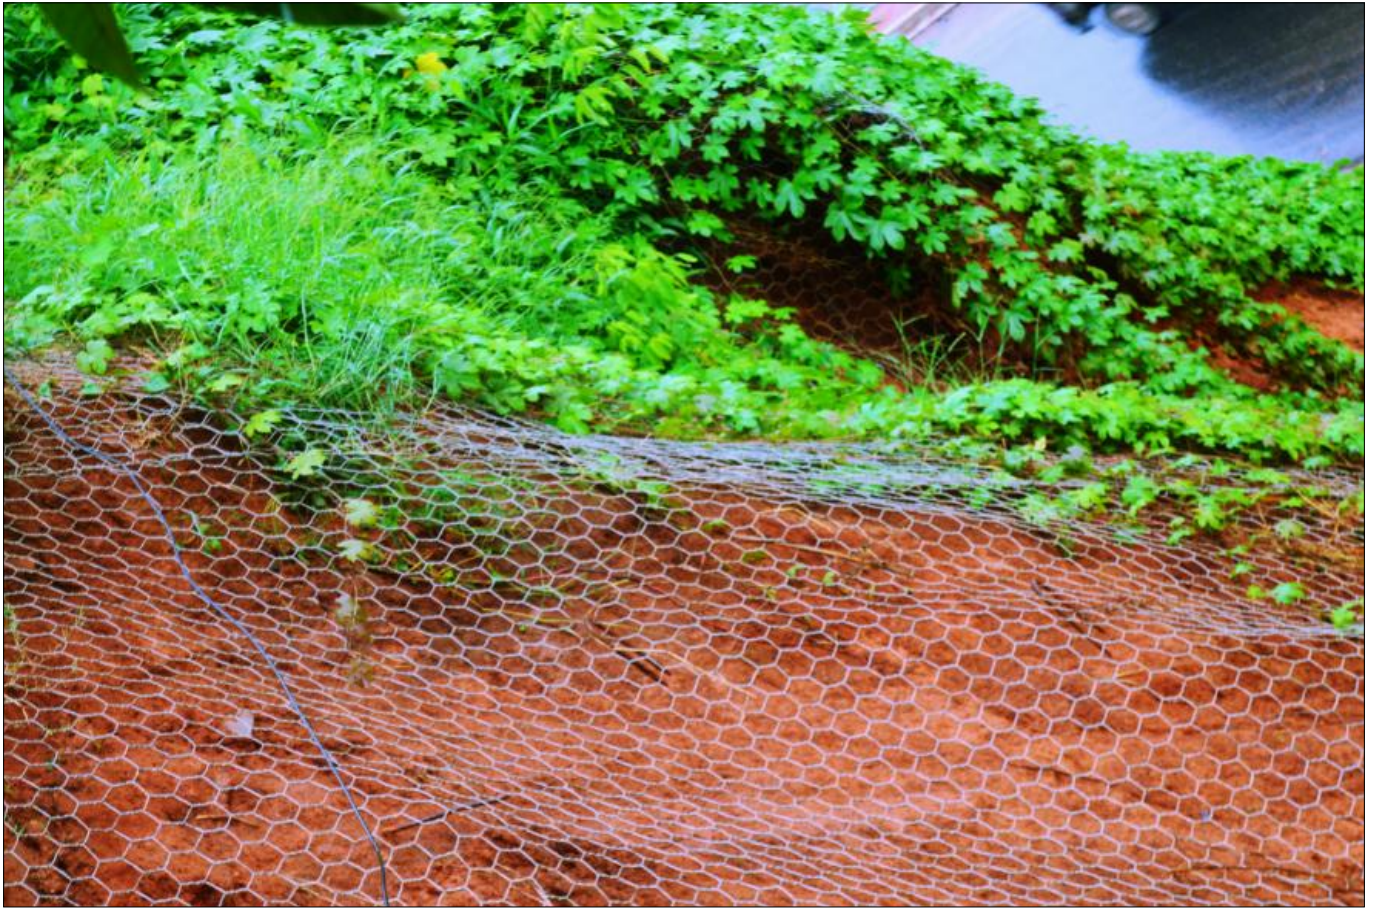
Structure after 7 years

It has been 7 years since project is completed. Rock fall protection system faced many worst monsoons still and the system is working as per the project requirement and desired by the client.
