# PROJECT REPORT

| Project Name | : | Flood Protection Works on the Downstream of River Ghaghara at Lakhimpur Kheri, Uttar Pradesh |

### **3. DESIGN OF FLOOD PROTECTION WORKS ON DOWNSTREAM OF RIVER GHAGHARA AT LAKHIMPUR**

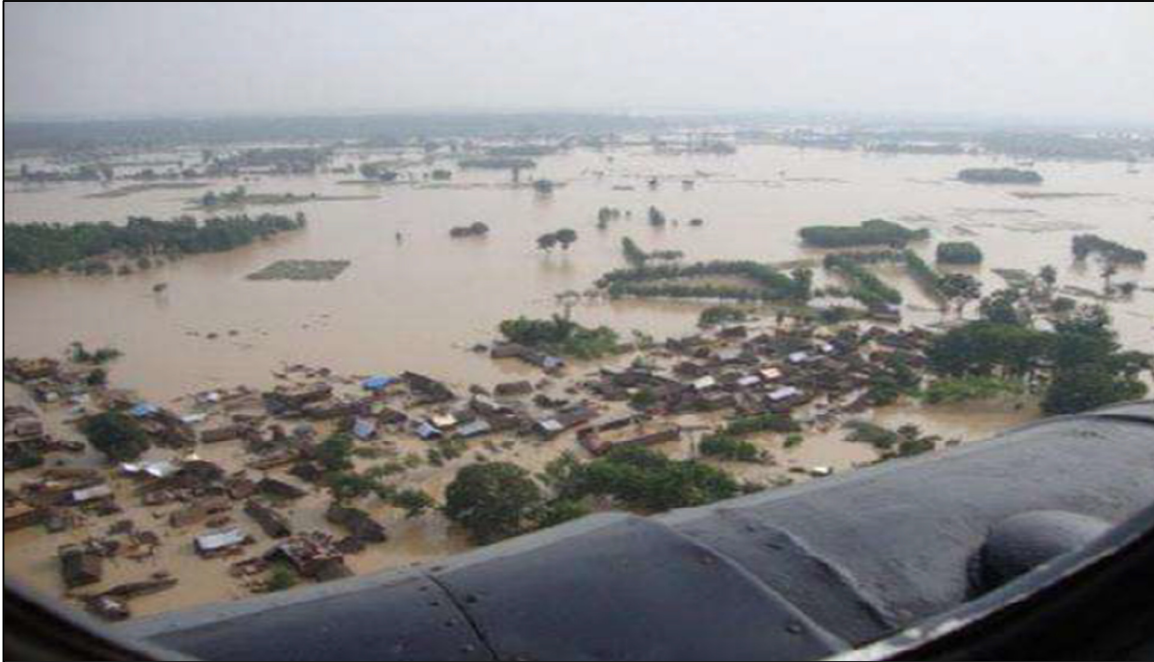
*Figure 1. During flood situation*

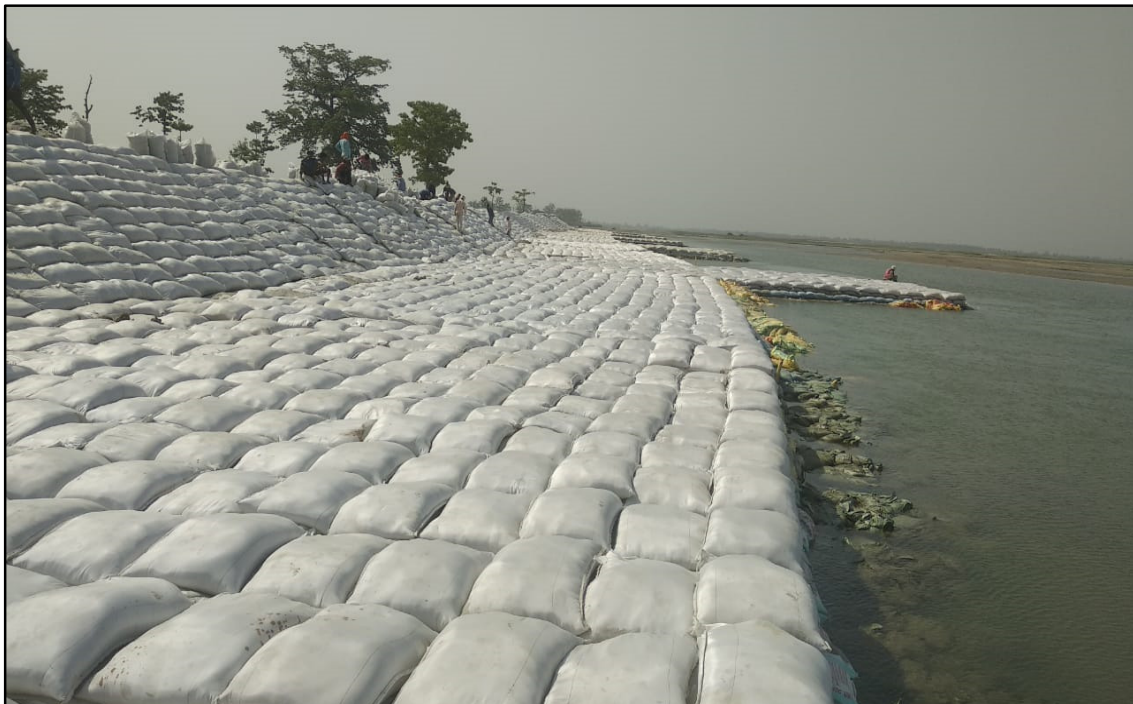
*Figure 3 Photograph after Construction*

The proposed design is technically efficient and economical as compared to the conventional approach; big boulders or CC Blocks are used for river training work. It is observed that the Completed Geotextile bag's structure withstood the recent floods for last two years without any major damage to the properties, loss of land or loss of any cattle or people. The protection is serving as desired by the authority. It is also observed that the river has maintained its natural flow profile during the monsoon season.
