## CASE HISTORY

### REINFORCED SOIL WALL FOR A PRIVATE BUNGALOW IN AAMBY- VALLEY LONAVALA, MAHARASHTRA

LONAVALA, MAHARASHTRA, INDIA

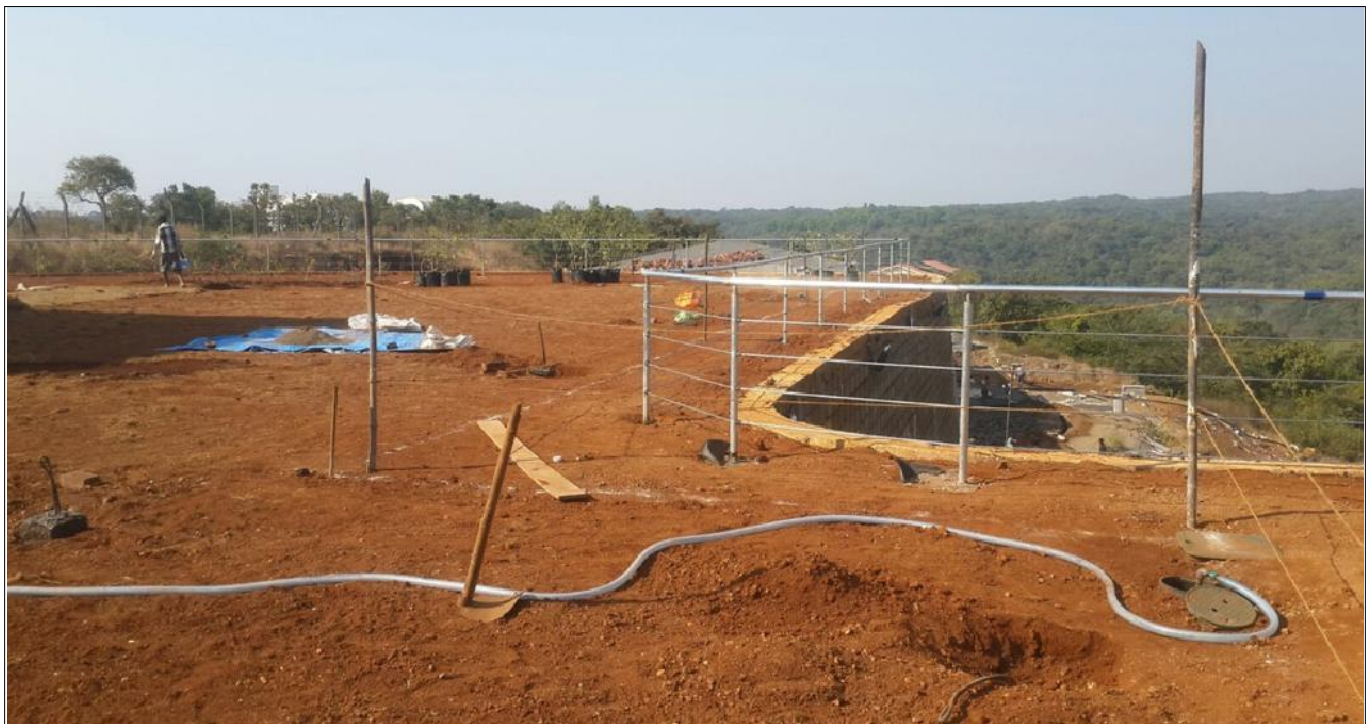
Fig 1 : During Construction

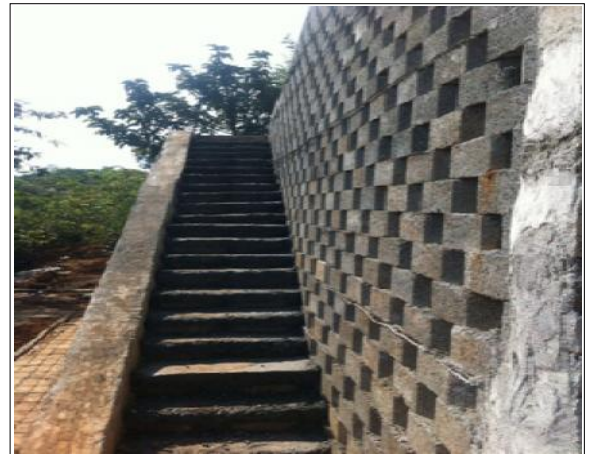
**Fig 2 : Stairs over reinforcement**

The main attraction as noted from Fig 3 is the stairs which were constructed on the wall, wherein the TechGrid was not disturbed and was laid as per design criteria.

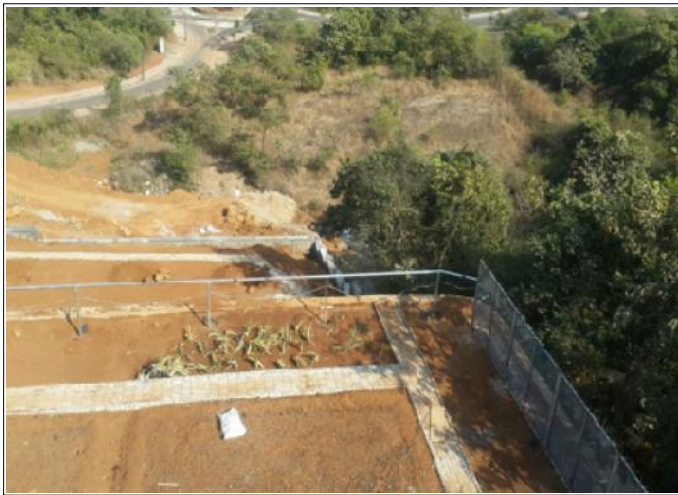
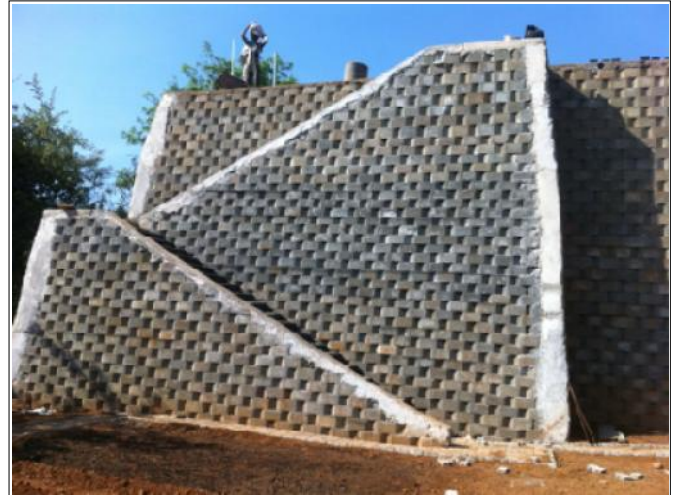
**Fig 3 : During Construction**

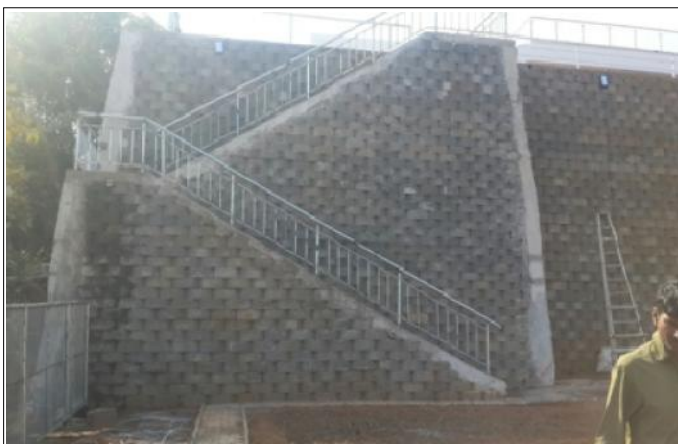
**Fig 4 : After Construction of stairs**

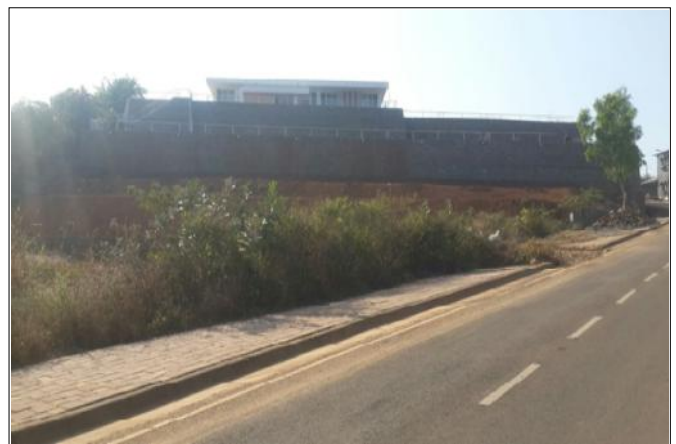
**Fig 5 : After Construction - View from far**

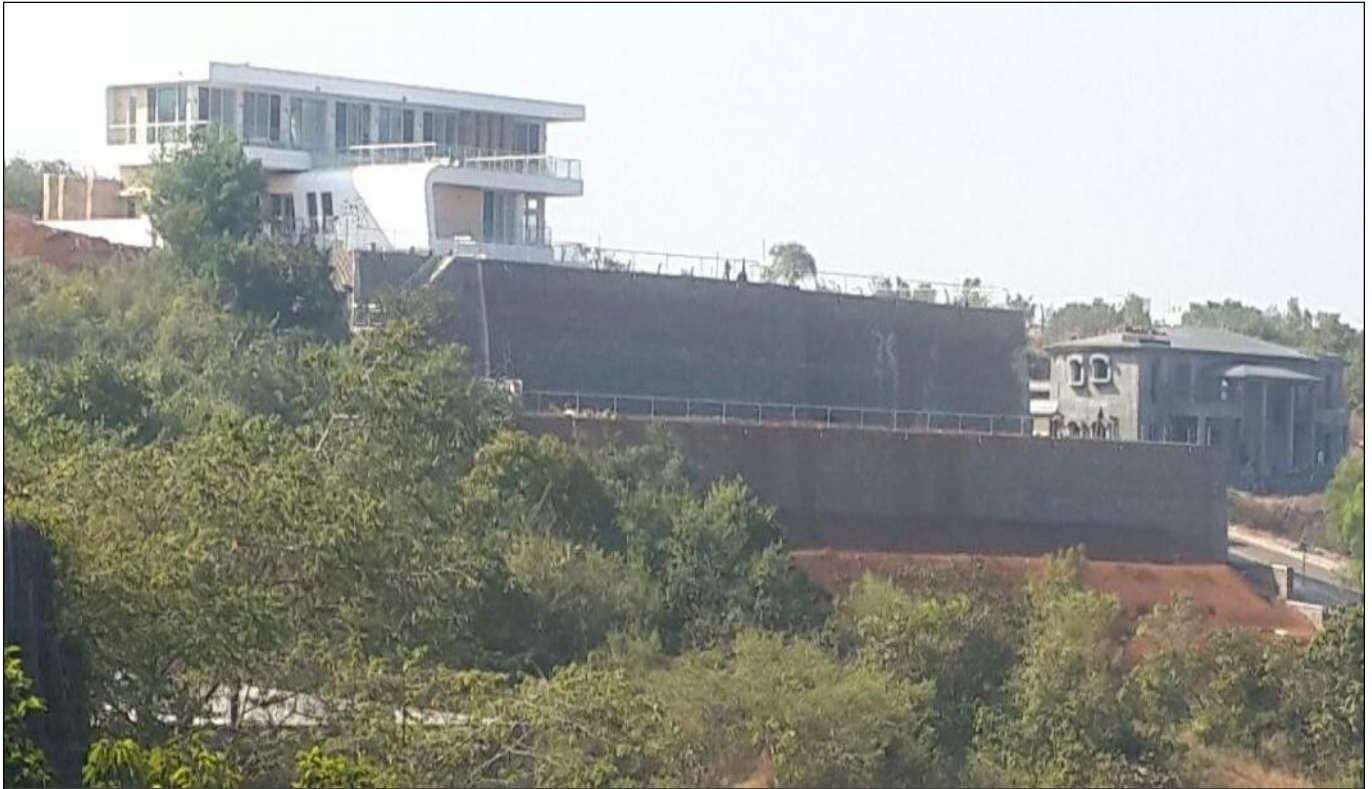
**Fig 6 : Structure after Construction**

Aamby valley is a meticulously planned city with world-class infrastructure and facilities, offering everything one needs for premium living. The client bungalow was situated on steep slope of around 70 to 80 degree of height around 16m as seen from Fig 6. The problem client was facing was the same as most of the owners in Aamby Valley do. Scouring was acute at some places which lead to collapse of the soil wedges, further leading to slope stability failure. Rains in Aamby valley are also very heavy. The type of soil there is of lateritic and basaltic origin, it acts like a hard rock in summer and flows with rain during rains. During monsoon the situation would worsen up again. A long-term solution was what the client was requiring.

The height to be protected also was very high and a single whole stretch wall was not a safe solution, a berm of 6m was provided after a height of 6m. After which the remaining height of 10m height was constructed. The client did not face space restriction, which became a boon for us.
