FLOOD PROTECTION WORKS ON THE DOWNSTREAM OF RIVER SHARDA / GHAGHARA AT LAKHIMPUR, UTTAR PRADESH

LAKHIMPUR, UTTAR PRADESH, INDIA

Flood Protection Works

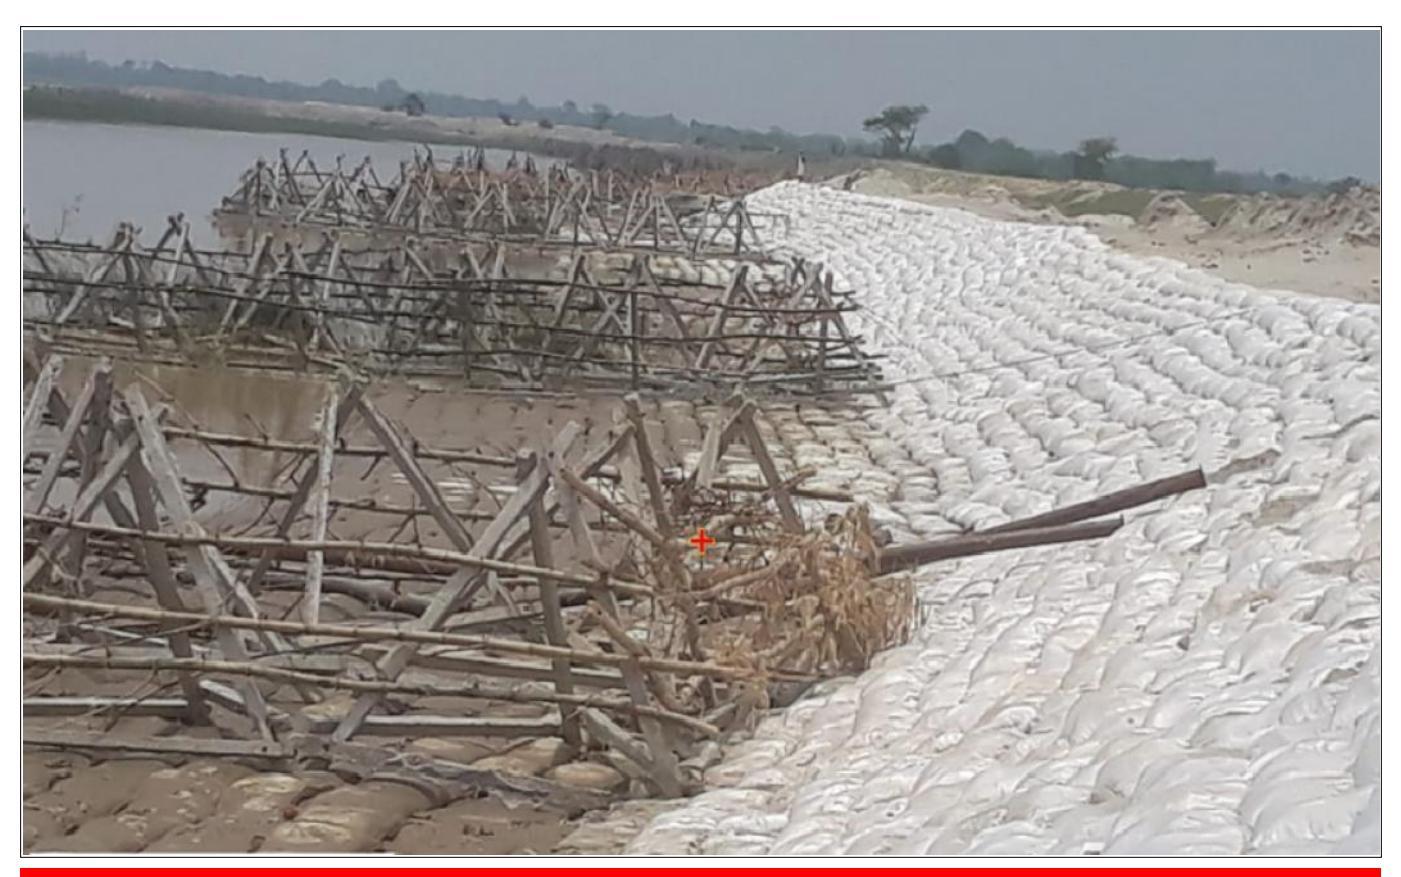
Groynes / spurs are constructed transverse to the river flow extending from the bank into the river. This form of river training works perform one or more functions such as training the river along the desired course to reduce the concentration of flow at the point of attack, creating a slack flow for silting up the area in the vicinity and protecting the bank by keeping the flow away from it.

Photo 3: Porcupine concrete spurs

- Laying of bags was done under supervision of the site in charge. Laying work was inspected time to time by authority.
- Laying of porcupine concrete element was carried out as per drawings and installation guidelines for spur construction.

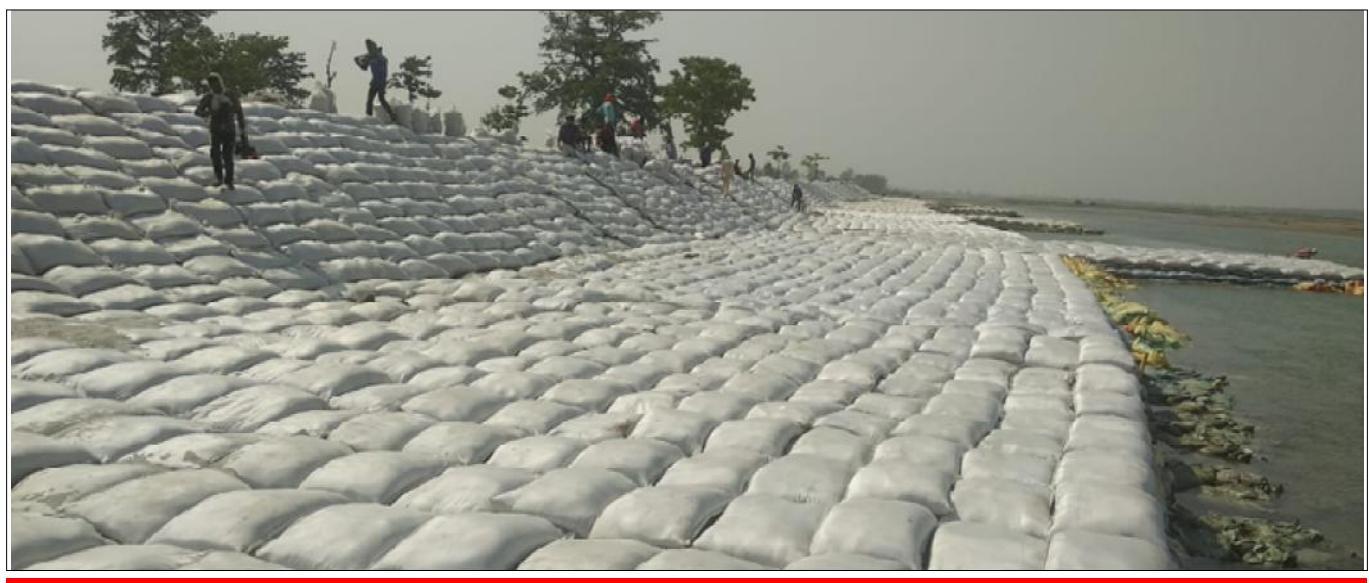
- The slope formation was done with necessary ramming to remove any undulations and corrected to the desired slope before laying nonwoven geotextile.
- The geotextile was laid across the dressed slope over which sand filled geotextile bags were placed.

- The bags were filled with locally available River Sand; the sand used as filling was as per technical specification of the project.
- After sand filling was completed, the geotextile bag was weighed to confirm the desired weight as per technical requirement.

Photo 4: The Flood protection work / dikes using geotextile bags

It is observed that Completed Geotextile bags structure withstood recent flood of 2019 without any major damage of the properties, loss of land and without loss of any cattle or people. The protection is serving as desired by the authority. It is also observed that the river has changed its course @ 9 -10m from its existing flow profile and deposition of the sand at multiple locations.
