## CASE HISTORY

### LANDSLIDES MITIGATION MEASURES AT KM 63 NEAR CHAMBA TUNNEL ON RISHIKESH - DHARASU ROAD (NH-34), UTTARAKHAND UTTARAKHAND, INDIA

#### Rockfall Protection

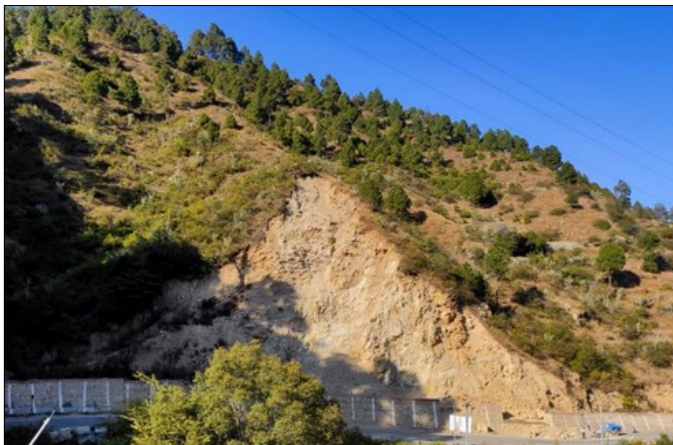
Slided Slope Mass

- During the widening of existing NH-34, the stability of slope mass has been disturbed by toe cutting.
- The slope has been cut at toe portion and the steep cut slope is standing at height of about 40-50 m without any intermediate benches.
- The area is prone to heavy rainfall and seismic activity falling under Seismic Zone-V.
- Closely spaced joints which are dipping opposite to the slope direction at the top portion may cause toppling failure due to steep cutting of slope.

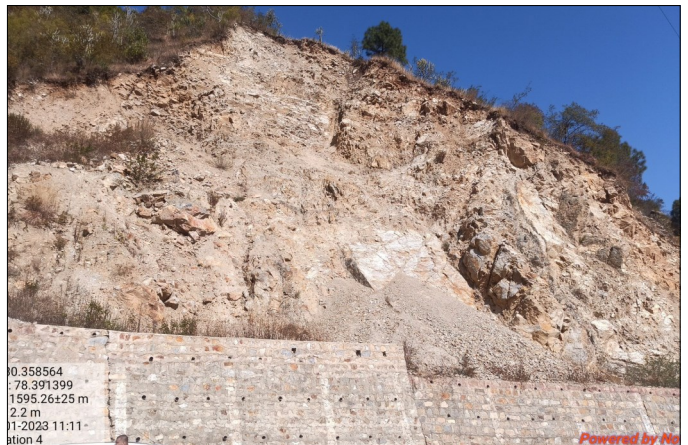
Slope Condition

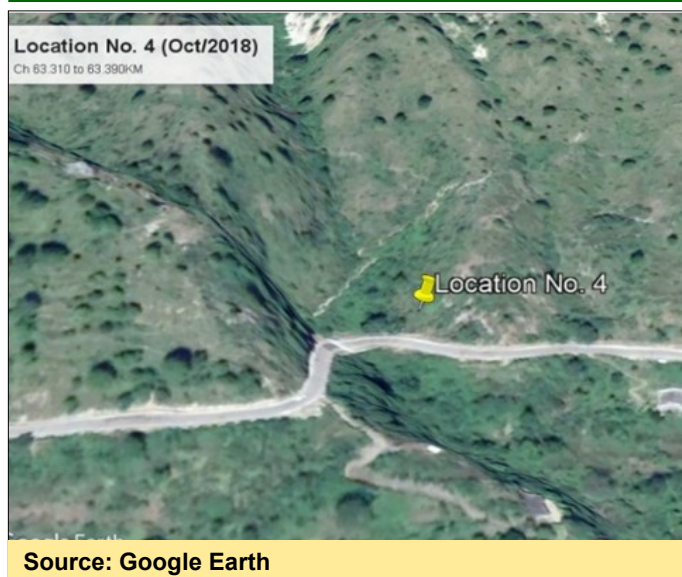
Slide Location (Before Road Widening, 2018)

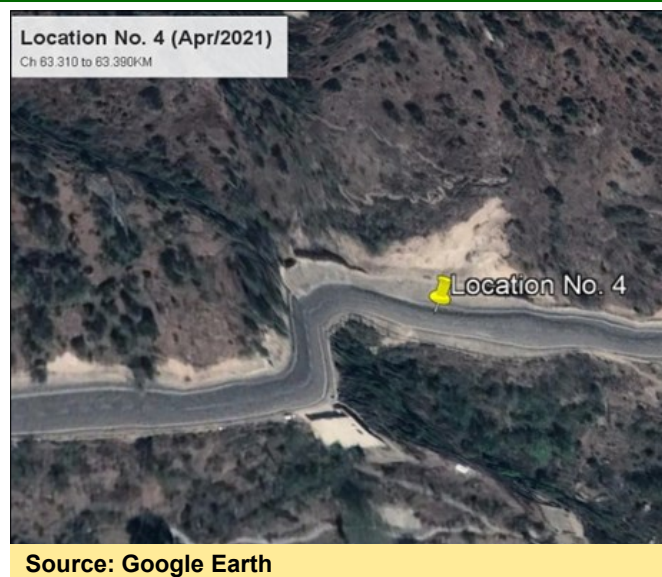
Slide Location (After Road Widening, 2021)

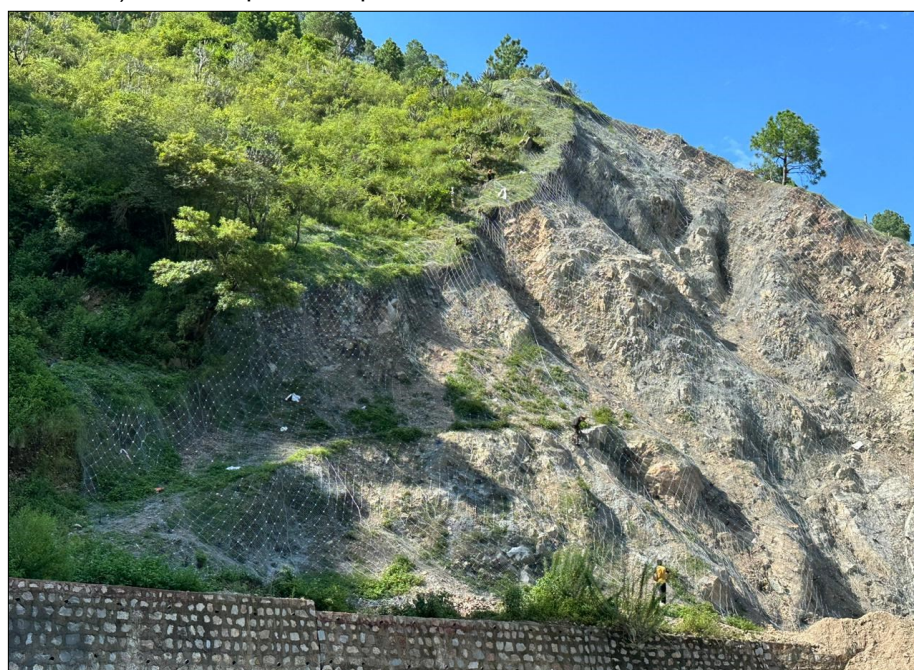
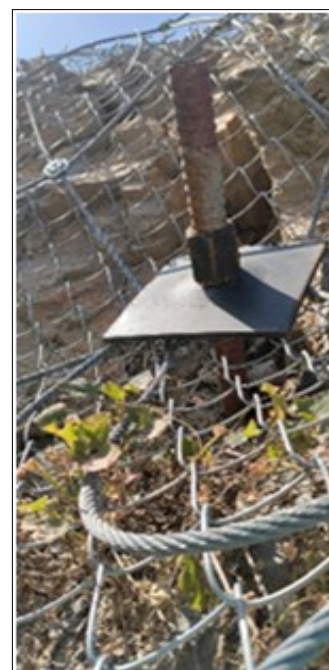
Proposed Solution on the Slope

- Loose scaling/trimming in isolated patches of unstable blocks or steep profile as per site conditions.
- Due to space restrictions on the hillside and valley side, Self-Drilling Anchors (SDA) of 6 m length spaced at 2.5 m c/c in both directions for maximum height of 47.5 m above existing wall is proposed. The soil anchors shall function as passive mitigation measures to address global instability.
- Considering the terrain and location of project, it has been proposed to provide the flexible fascia, i.e., high tensile steel wire mesh (TechRhombus as a Primary mesh and Double twisted wire mesh as a secondary mesh) for the exposed slope surface.

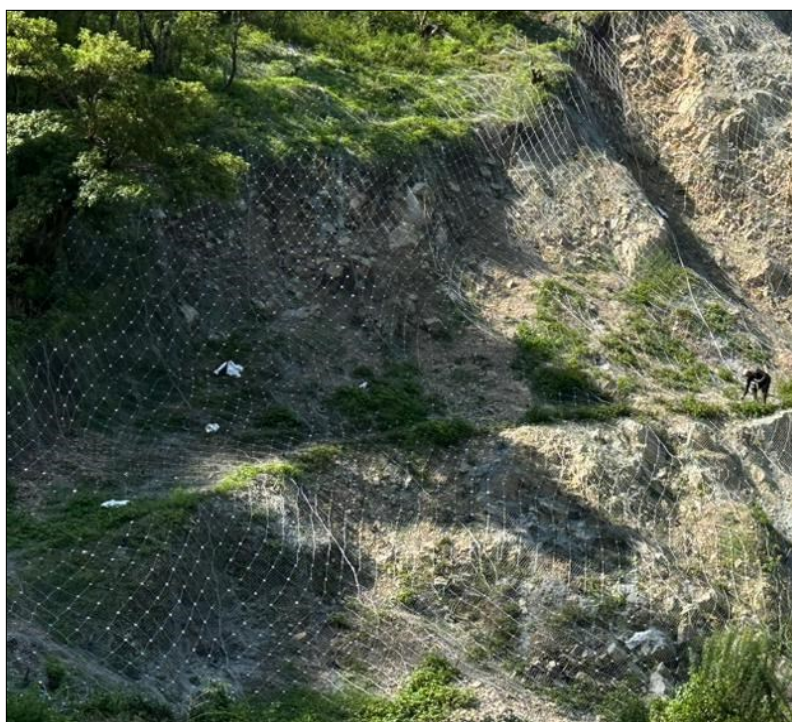
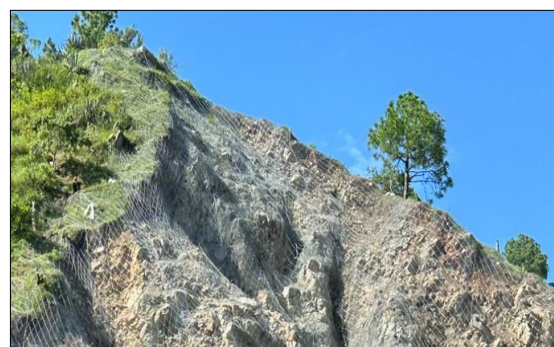
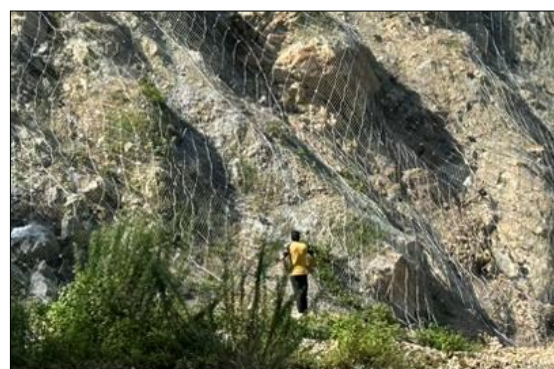
Installation works in progress

- The area is excavated/scaled up to the levels and slope as per the drawings.
- Marking is done on slope at the set locations and drilling was executed for installation of SDA.

- The anchorage system is installed with rotary percussive drilling and continuous grouting to cause minimum ground modification and disturbance possible.

- To contain grout, the typical inclination of drill hole is kept at around 10 degrees to horizontal inclining upwards.
- Grout Injection is carried out through hollow steel bar. Injection mixture flows through the holes at the sacrificial drill bit and automatically stabilizes the drilled hole.

- The rolls of DT Mesh are transported to the top of the slope (crane, winch or rope way system may be used) and the rolls are aligned on the upper edge.

- The rolls are opened and extended on the top for the designed run out length and are laid into the trenches over the anchors.
- The adjacent mesh lapping can be done by looping or ring system.

- Installation of TechRhombus Mesh with High Resistant Clip (HRC) to be done.
- TechRhombus consists of top and bottom cables which are composed by steel cables galvanized with a Zn-Al alloy galvanization.

- Meshes shall be rolled down till the required length and the base plates shall be fixed over the anchors and mesh and tightened
- Periodic maintenance shall be carried out after each rockfall event by clearing off the debris collected within the draped mesh.

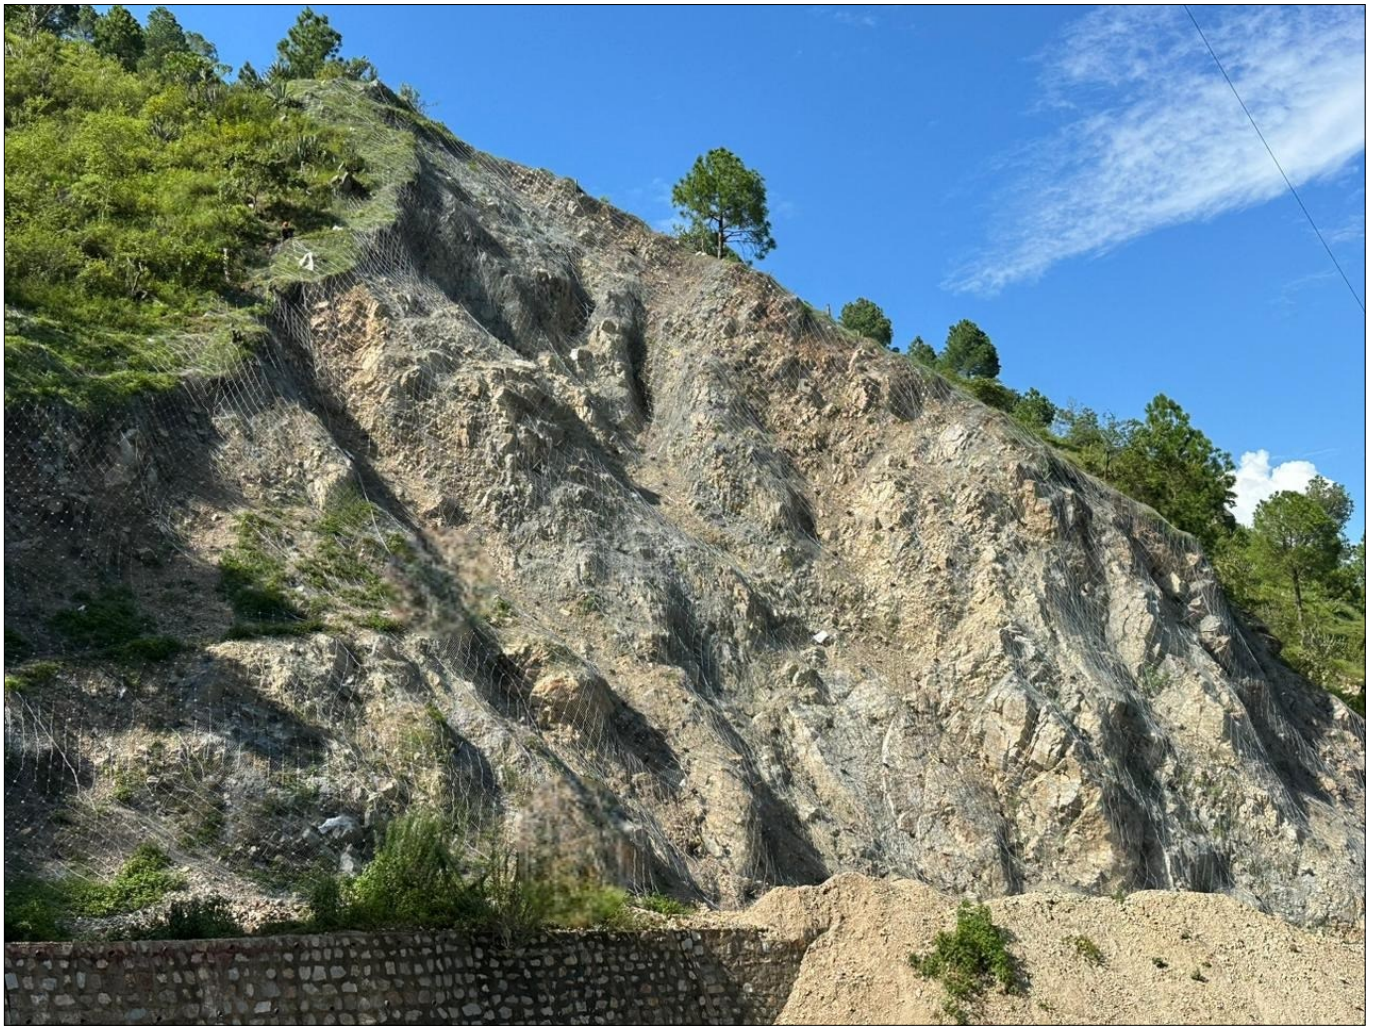
**Completed Structure**

Under this project, stabilization measures such as scaling of overhang rock cliffs, application of high tensile rolled cable net ,DT Mesh along with SDA have been envisaged without affecting existing structures, environment, and forest within the area. The protection is serving as desired by the authority. After stabilizing the affected vulnerable stretch of this road, uninterrupted traffic flow would certainly augment the regular movement of locals & by passers for their daily requirements in the region, which will naturally upgrade the economic conditions of the people belonging to the entire area.
